Heol Martin, Eglwysbach, Conwy
Proposed Residential Development:
Arboricultural Planning Assessment
(BS5837:2012)

Project no: WAL_24_016_P01

Heol Martin, Eglwysbach, Conwy : Proposed Residential Development
Arboricultural Assessment (BS5837:2012)

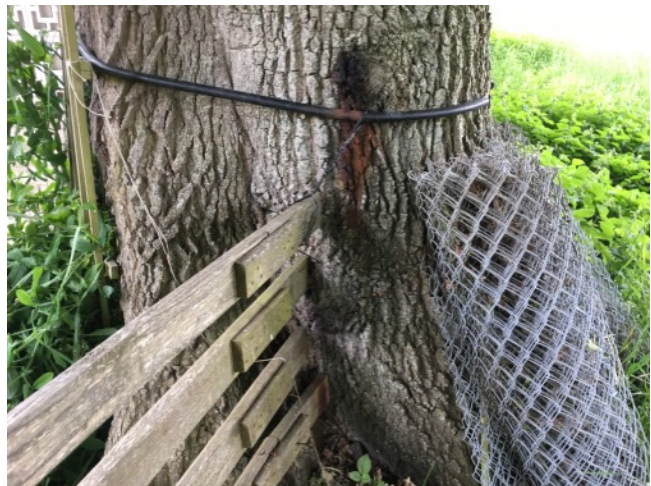
The most visually-significant tree on site is the oak, T1. The tree is on the left of the entrance, as seen from the existing road, and effectively frames the view of the site. The tree is in generally good health, although there are some "bleeds" on the lower stem. The cause of these bleeds may simply be a function of mechanical damage to the stem, but should nevertheless be monitored, as there is a significant pathogen of oak, namely *Phytophthora ramorum*, which can cause rapid decline in oak.

Fig 2: T1 weep

| Tag | Name | Age | Height (m) | DBH (mm) | RPA-R (m) | RPA-A (m2) | FSB (m) | Crown Spread N-E-S-W (m) | Comments | Recommendations | SULE | Category |
|---|---|---|---|---|---|---|---|---|--|--|---|---|
| T1 | Common Oak | OM | 18 | 1200 | 14.4 | 651.53 | 5SE | 6-11-9-13 | Good vitality. Good form. Spreading habit. Exudation on stem. Multiple stems above 1.5m. Minor dead wood in crown. Low branches over road/ footpath. | Avoid conflict with RPA. Erect protective fencing to extent of RPA. Remove major deadwood. Crown lift to 5m. | 20 | A3 |

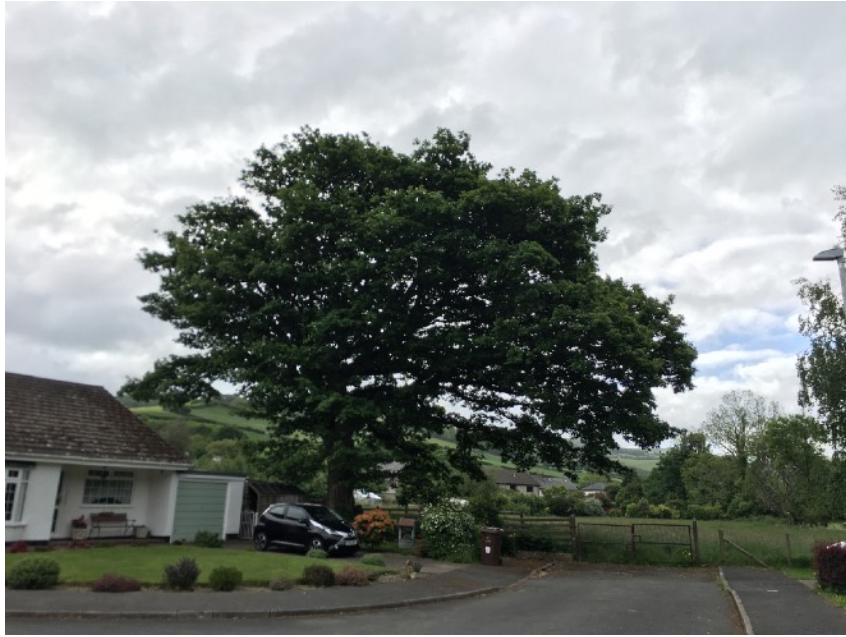
Fig 3: T1 in context

T1's Root Protection Area (RPA) overlaps the proposed drive to an extent of 5.6% of the total RPA, which would not generally equate to a major loss of roots. However, this depends to a certain extent on the size and significance of the root impacted. For this reason I recommend that an exploratory trench be dug using an Airspade. An Airspade is a compressed air tool which propels air into the soil and can blow the soil out of the trench, while not significantly damaging the tree's roots. In this way, we can explore to actual root size, condition and distribution along the overlap line with the drive. If sub-75mm roots are encountered, then we should be able to simply carefully sever the roots on the road side with hand tools, and build conventionally. If very large roots are encountered, we may need to consider an alternative method.

| Arboricultural Solutions Matrix | | |
|---|--|---|
| 1 | The maximum RPA of T1 overlaps the proposed entrance drive into the site by 9.2% (60.245 sq.m of a total RPA of 651.4 sq.m). | <p>As part of the investigation phase, a linear trench of 14m x 0.6m x 0.8M shall be created with an Air Spade. This investigation will reveal any significant roots (in excess of 75mm diameter) from T1. If there are not significant roots over this threshold, then they may be pruned back with hand tools, and the drive can be built conventionally.</p> <p>If there are significant numbers of large roots found in the trench, then an above-ground construction solution should be devised in the position shown on sheet 3 of the plan set. This will involve minimal excavation (stripping of surface vegetation, essentially) within the RPA of T1, and that all buildup will comprise a Cellweb cellular confinement system. As part of the detailed design stage, a comprehensive and engineered set of construction drawings will be produced for this section of the drive. All key work stages will be supervised by the project arboriculturist.</p> |

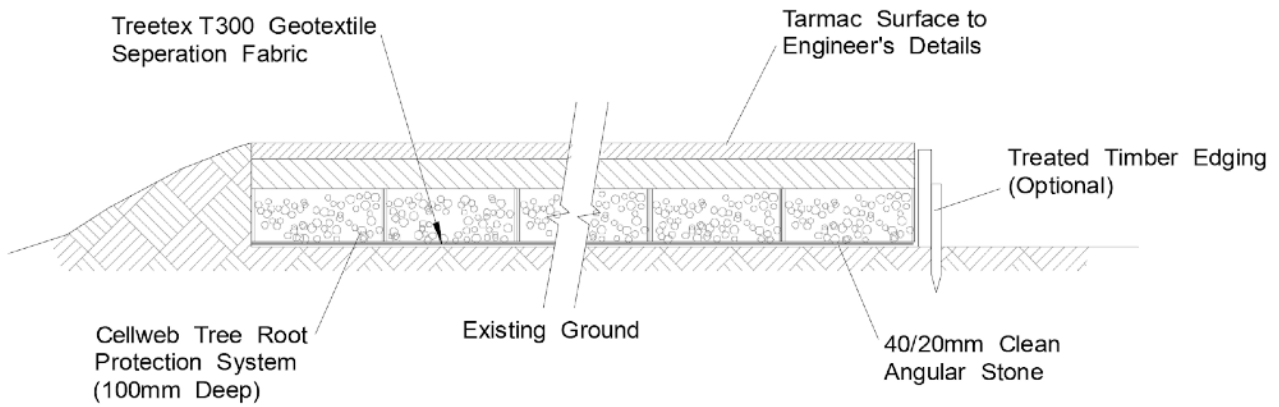
If we judge that the construction of the drive will significantly impact the roots of T1, an above-ground, "no-dig" paving solution is proposed. The areas involved is shown with a blue, hexagonal hatch on the enclosed Tree Protection Plan (*WAL_24_016 Heol Martin Sheet 3/3 Tree Protection Plan (1:500@A3)*).

In order to construct this section of the driveway without digging substantially down into soil over the mapped RPAs, a cellular confinement system, or geocell grid will be used in a configuration along the lines of that shown in Figure 4, below. Geocell, such as Geosynthetic's Cellweb (<http://www.geosyn.co.uk/product/cellweb-tree-root-protection>), would be a suitable product for this application. I have personally been specifying and installing geogrids to raft over RPAs of retained trees for over 15 years, and have had great success with them, particularly now that more and more contractors are gaining experience in installing them correctly.

Fig 4: Typical section for no-dig construction build up
