Bryn Morfa, Bodelwyddan

Infiltration Test Report

October 2019

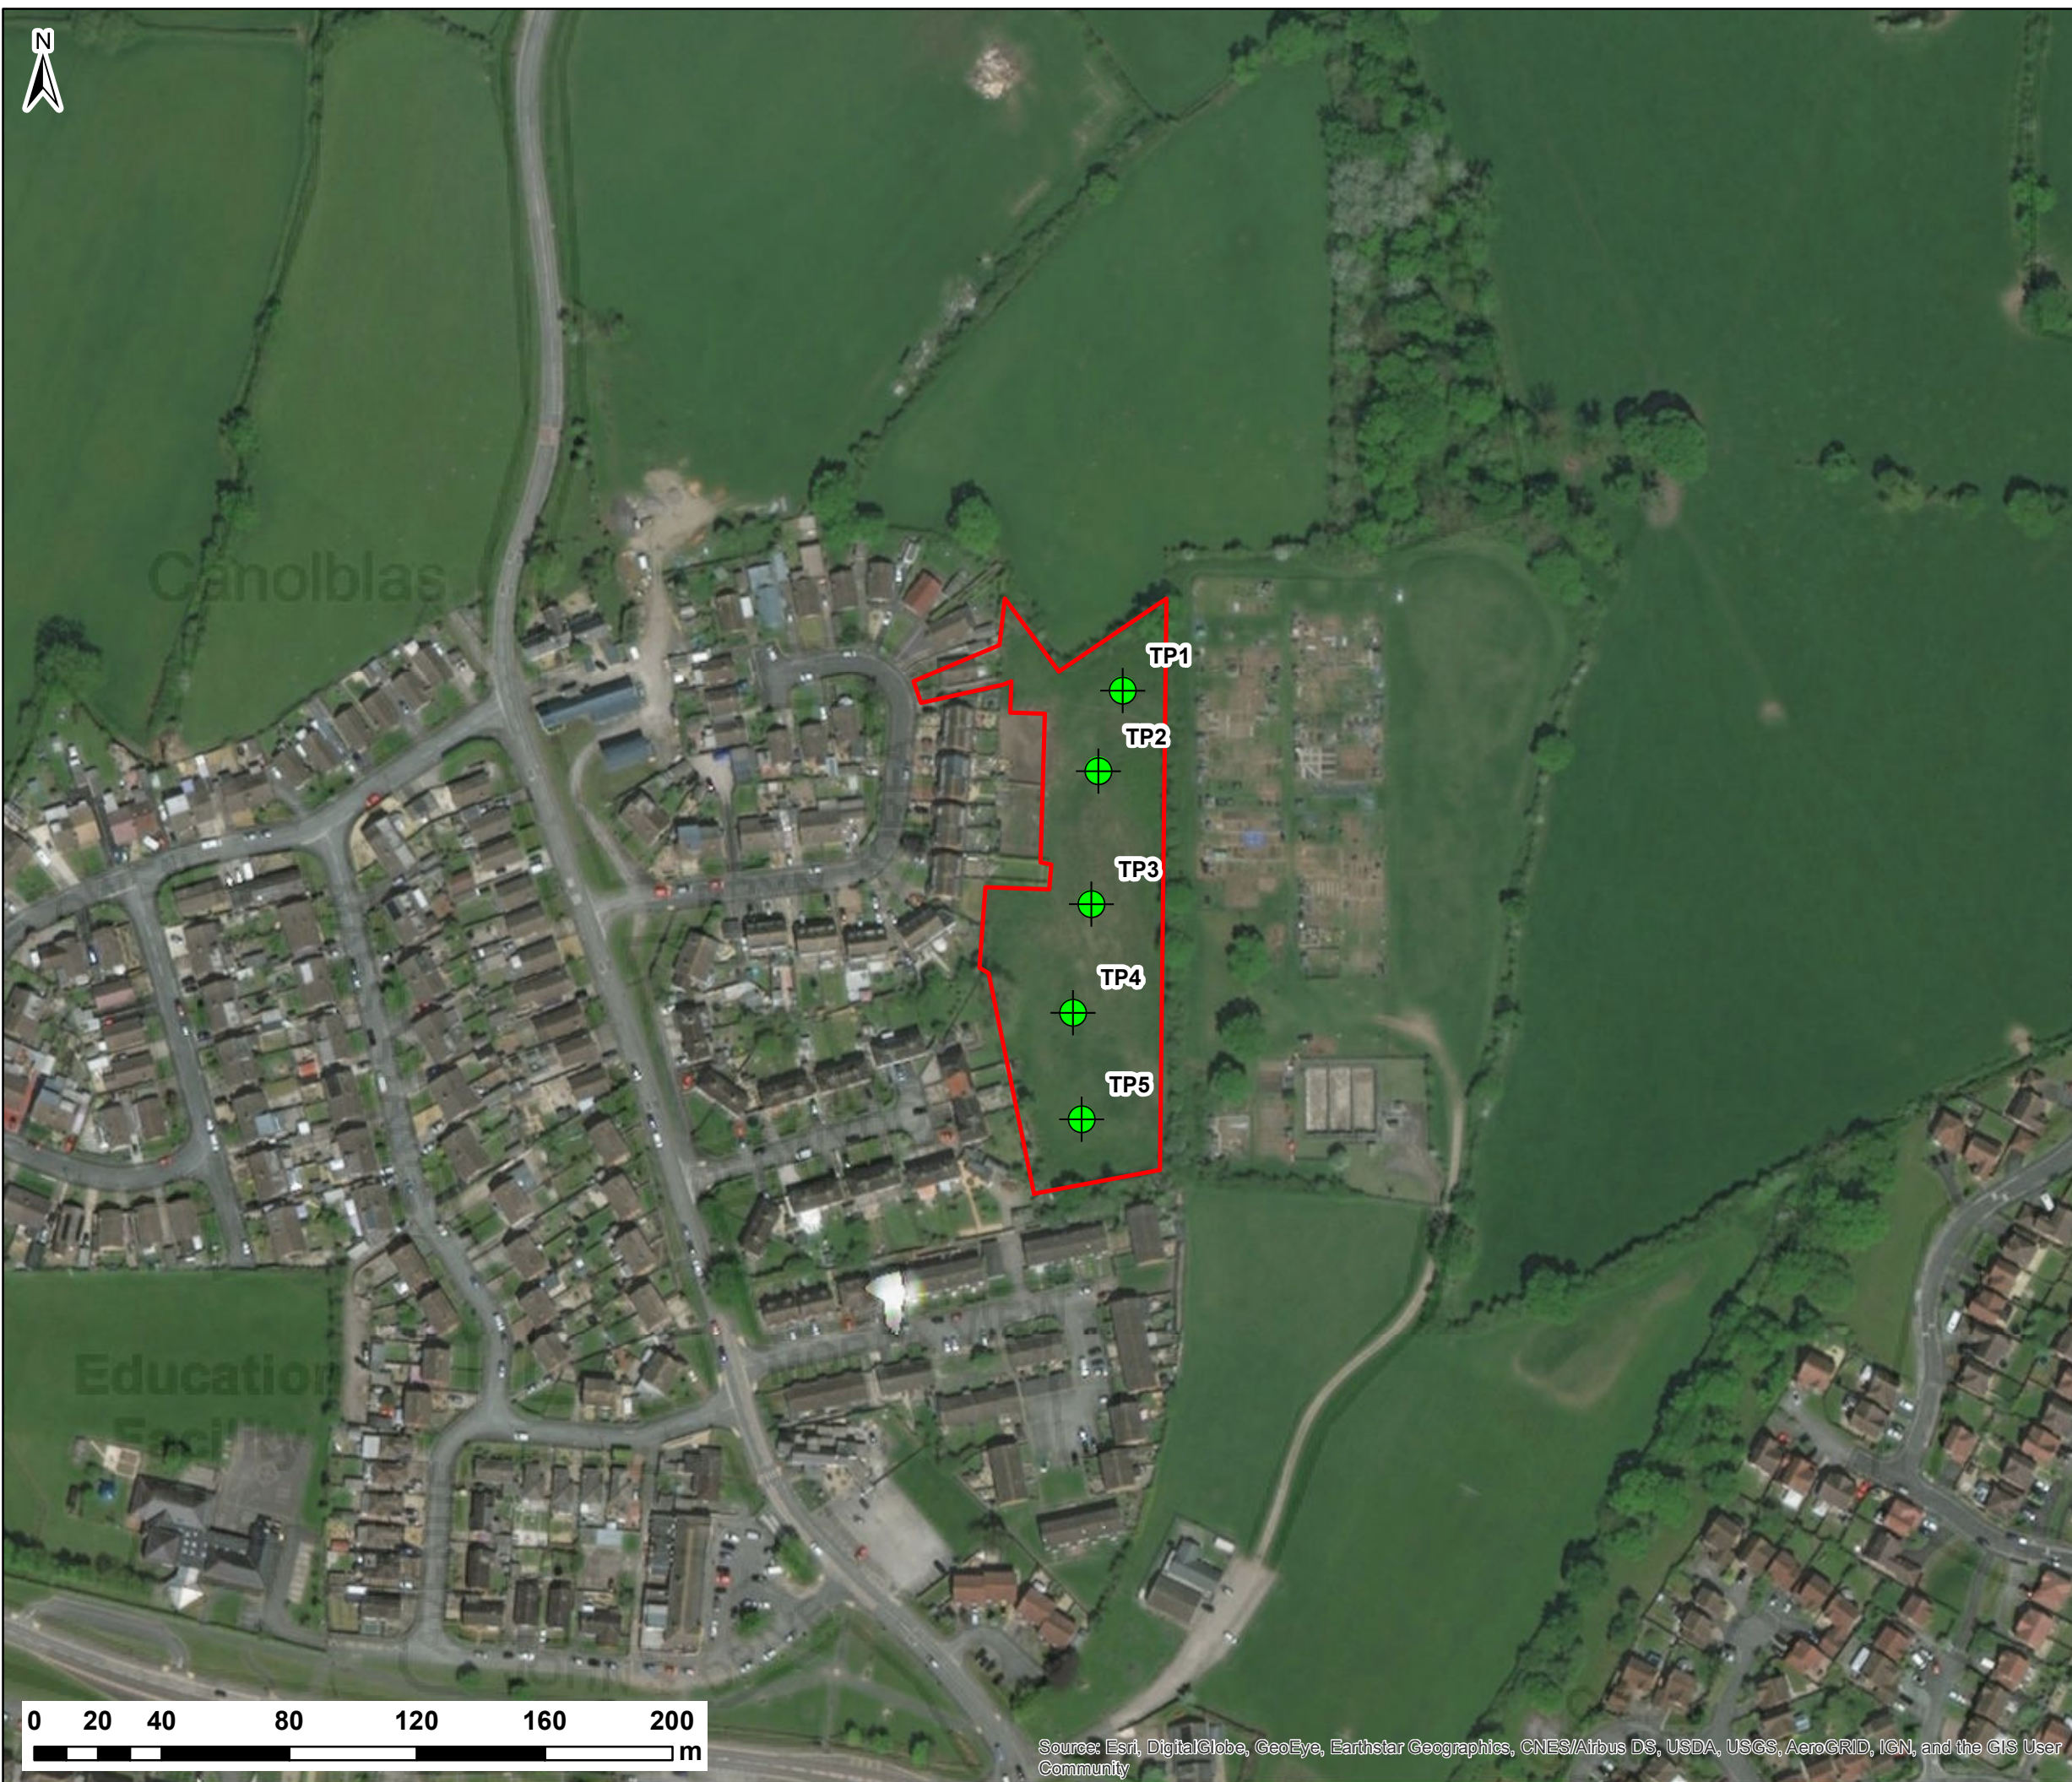
**TRIAL PIT
LOCATION PLAN**

The trial pits were dispersed across the site and positioned with respect to health and safety considerations and other on-site constraints. Approximate trial pit (TP) locations are annotated on the trial pit location plan in Appendix C. A photographic record is also included in Appendix C.

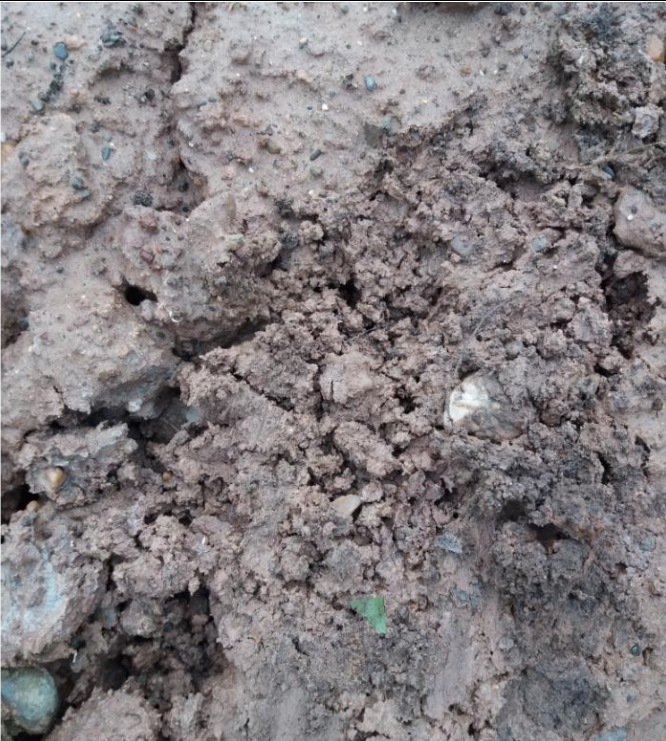
Photo No.8	Job Reference & Number: 12188 – Bryn Morfa, Bodelwyddan	
Date: October 2019

The excavated material comprised topsoil to a depth of approximately 0.3 metres below ground level (m.bgl). The topsoil was underlain by sandy, gravelly **clay**. Clay was encountered to a depth of 2m.bgl.

Description: Trial pit 4 arisings – clay in matrix of sands and gravel

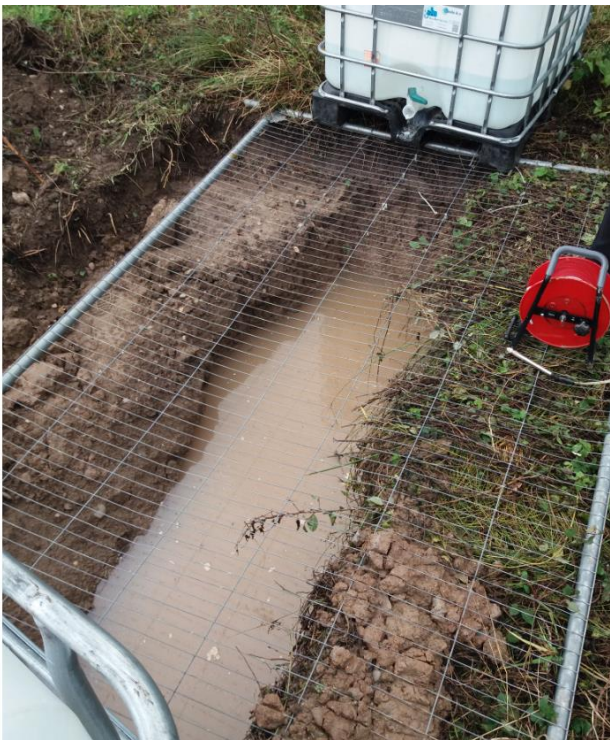
Photo No.9	Job Reference & Number: 12188 – Bryn Morfa, Bodelwyddan
Date: October 2019

Nevertheless, the trial pits were filled with water and the water level recorded over a period of 4 hours. The water level had minimal fall (less than 5cm within all trial pits).

Description: Trial pit 5, after infill of water

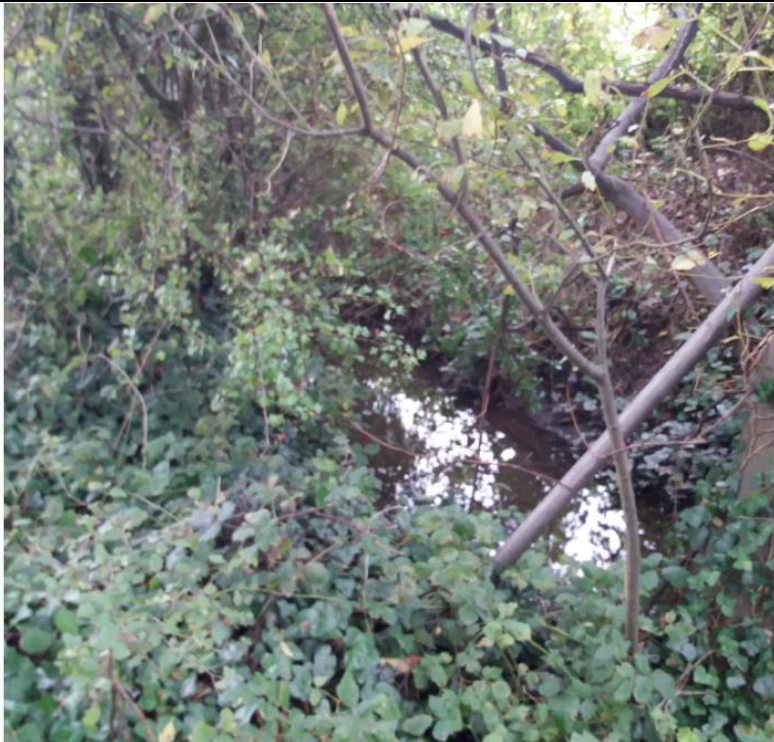
Photo No.13	Job Reference & Number: 12188 – Bryn Morfa, Bodelwyddan	
Date: October 2019

The site is currently undeveloped. The site is bordered by agricultural land to the north, Bodelwyddan allotments to the east and residential properties to the south and west. Access to the site is provided from Bryn Morfa (road) to the west. A land drain was recorded along the eastern site boundary flowing north.

Description: Land drain adjacent to eastern site boundary – facing north.

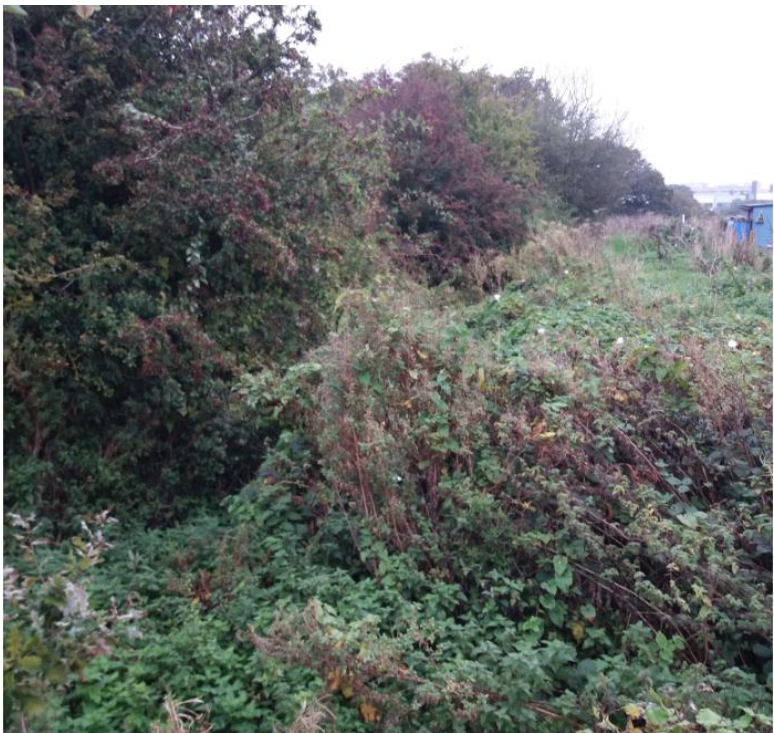
Photo No.14	Job Reference & Number: 12188 – Bryn Morfa, Bodelwyddan	
Date: October 2019

Description: Location of land drain, from the north-eastern corner of the site - facing east

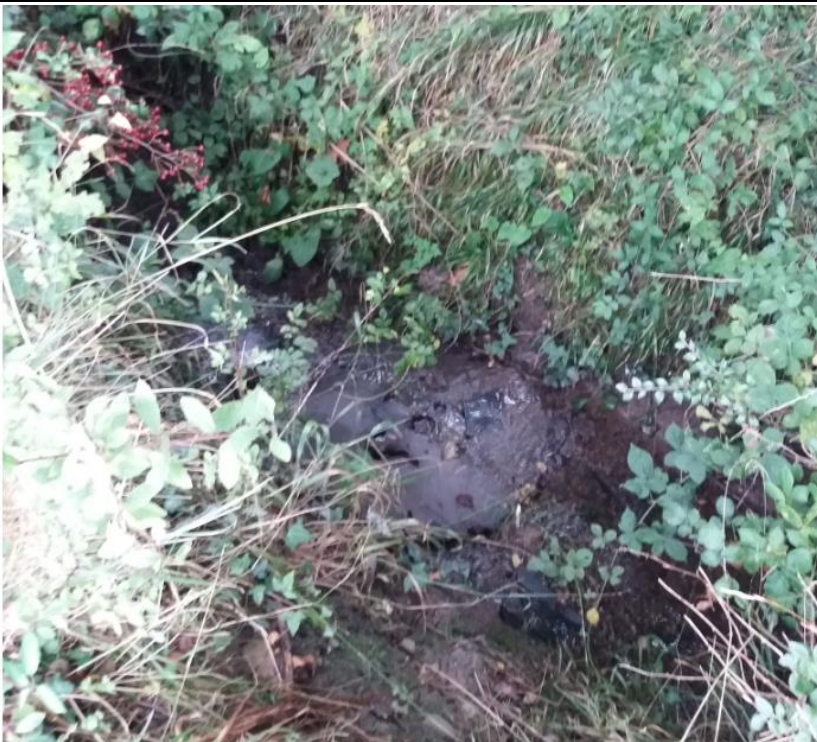
Photo No.15	Job Reference & Number: 12188 – Bryn Morfa, Bodelwyddan	
Date: October 2019		
Description: Land drain, taken from field north of the site, facing south.
