**FOREST HOLIDAYS**

**WOODLAND MANAGEMENT PLAN 2024**

Date: November 2024

**Forest Holidays Beddgelert  
 Woodland Compartment Plan**

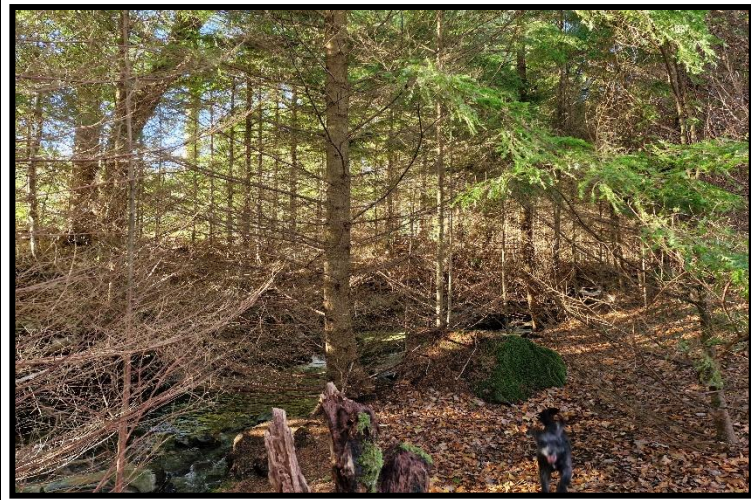
Photograph 1: Compartment 1.  
High density hemlock  
regeneration along river edge.

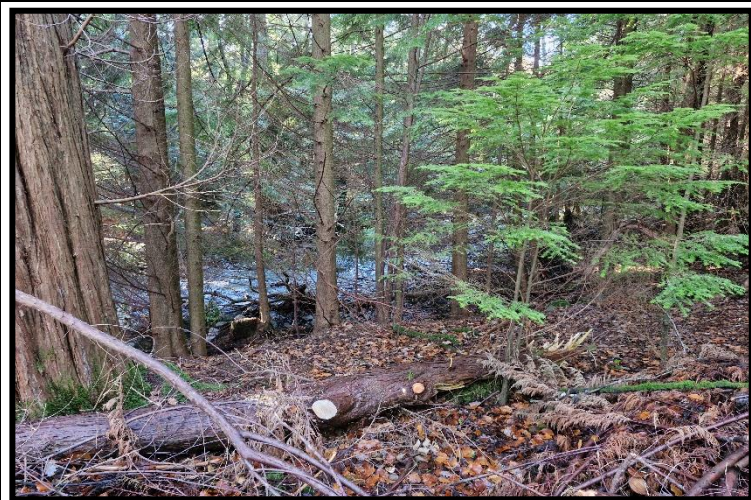
Photograph 2: Compartment 1.  
High density hemlock  
regeneration along river edge.

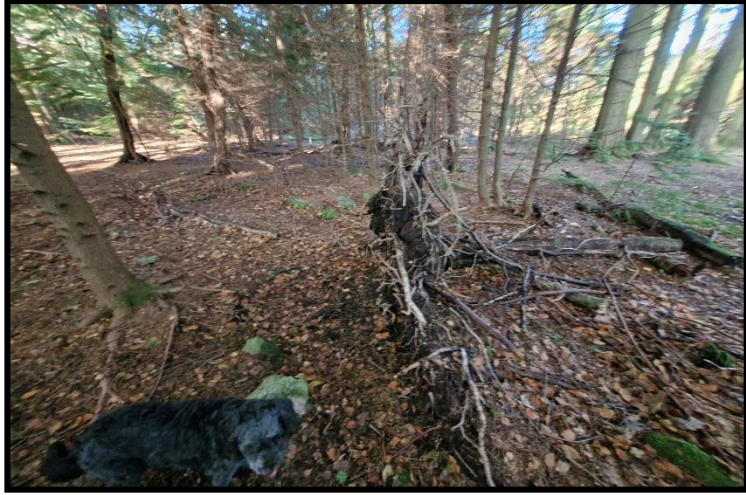
Photograph 3: Compartment 1.  
Evidence of historic windthrow,  
shallow peat soils over bedrock.

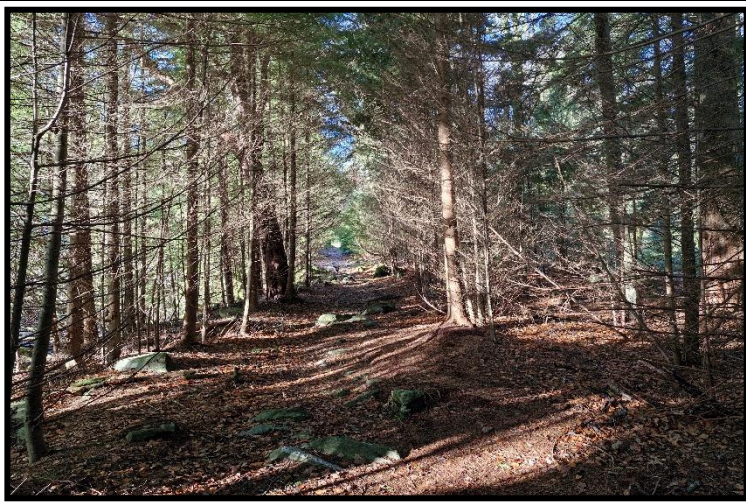
Photograph 4: Compartment 1.  
High-density Hemlock requiring  
gentle regular thinning.

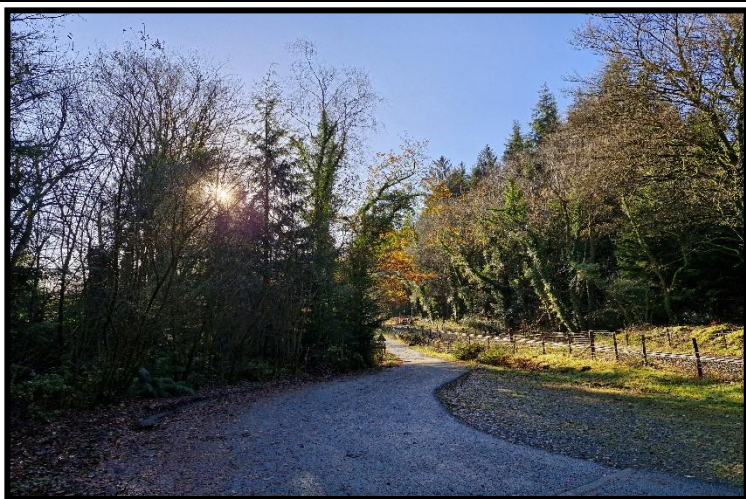
Photograph 5: Compartment 1.  
Developing western edge of  
woodland adjacent to railway,  
requiring ongoing management.

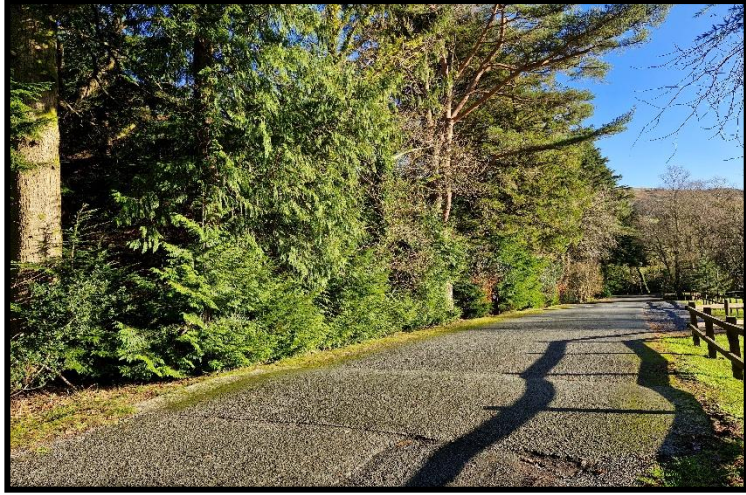
Photograph 6: Compartment 1. High canopy trees to edge of access road. Gradual management required to achieve graduated woodland edge and diverse habitat.

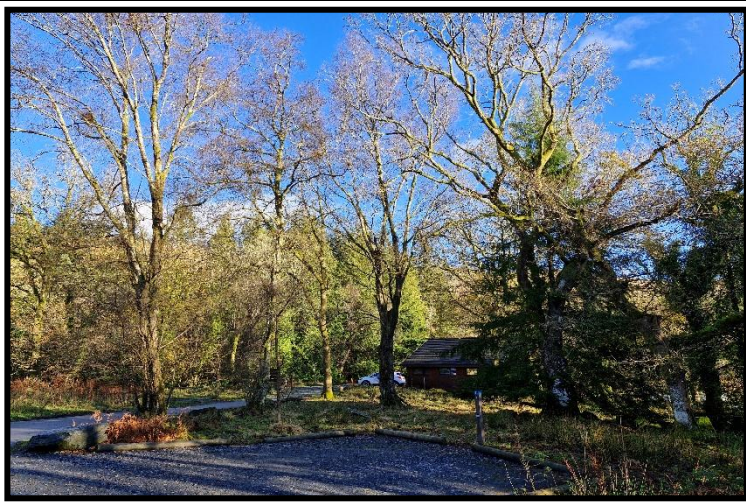
Photograph 7: Compartment 2. Oak and Birch woodland of more widely spaced trees

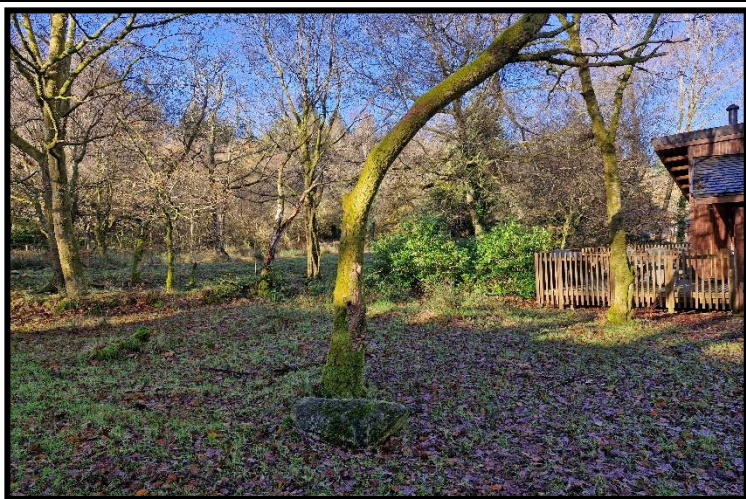
Photograph 8: Compartment 2. Developing Rhododendron clumps developing in all compartments requiring eradication.

- 5.5 Invasive plants including Rhododendron, Laurel and Japanese Knotweed is widespread, especially along river corridors, and needs to be removed. Stems should be cut to ground level, and stumps treated with an approved herbicide. Alternatively, stems can be treated by injection, with any remaining growth cleared after it dies back. All waste must be chipped and taken off-site, with follow-up spraying to stop regrowth if needed. Herbicides must be used in line with current rules on pesticides and the environment, taking extra care to protect rivers and water bodies.

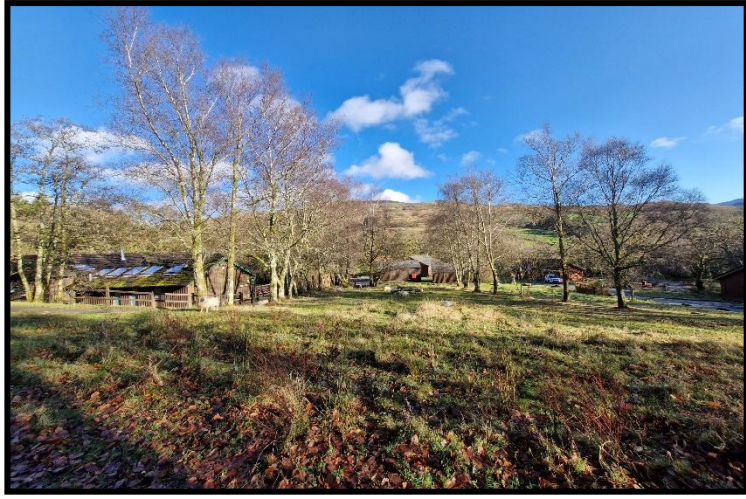
Photograph 9: All Compartments. Sheep entering the site and browsing former planting areas. New planting requiring individual protection or fencing.

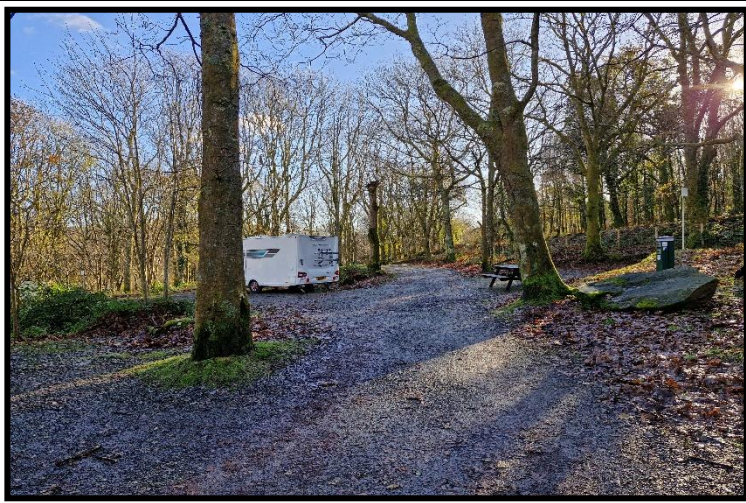
Photograph 10: Compartment 3. Heavily compacted ground conditions due to pitch and road use.

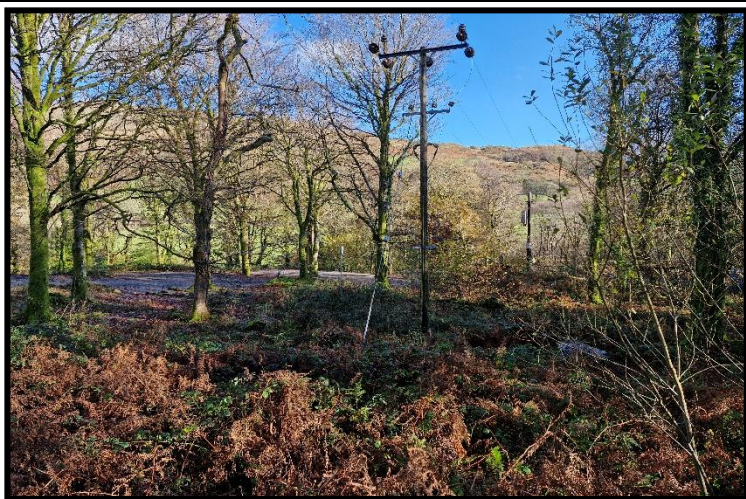
Photograph 11: Compartment 3. Overhead HV cable through southern part of group

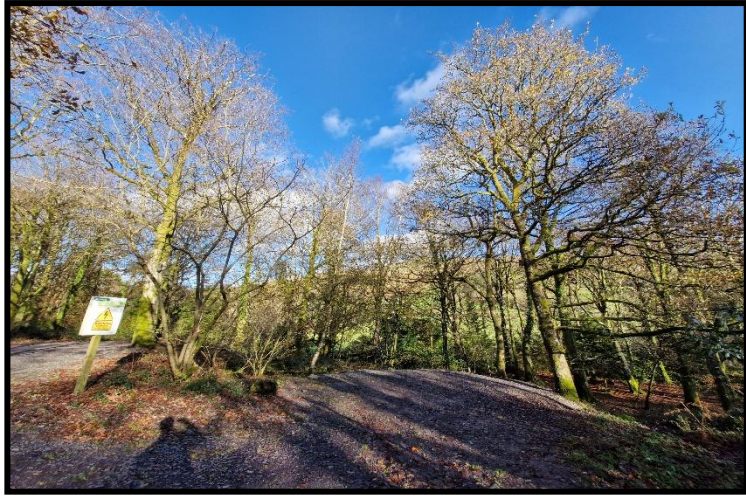
Photograph 12: Compartment 3.  
Poorly drained waterlogged  
ground conditions. Surfaces  
being eroded by heavy rain.

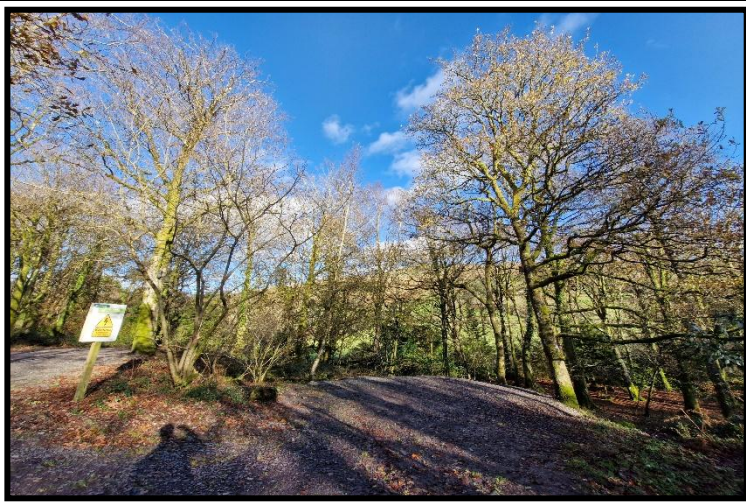
Photograph 13: Compartment 3.  
Poorly drained waterlogged  
ground conditions. Surfaces  
being eroded by heavy rain.

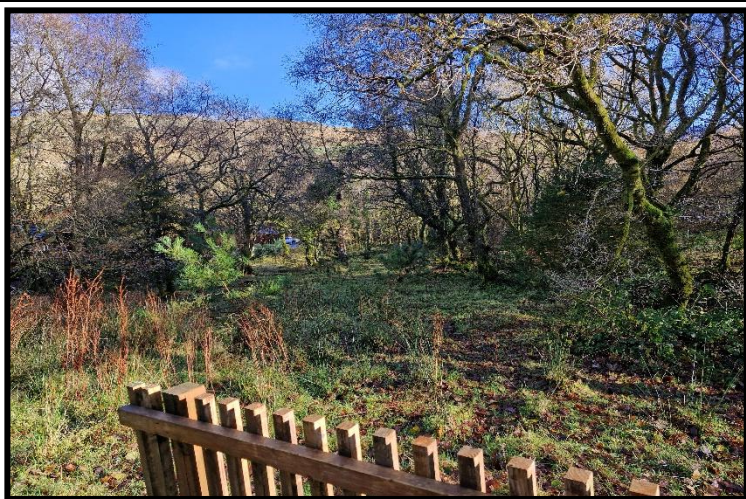
Photograph 14: Compartment 4.  
Poorly drained waterlogged  
ground conditions. Oak and Birch  
woodland with Willow and Hazel  
understory.

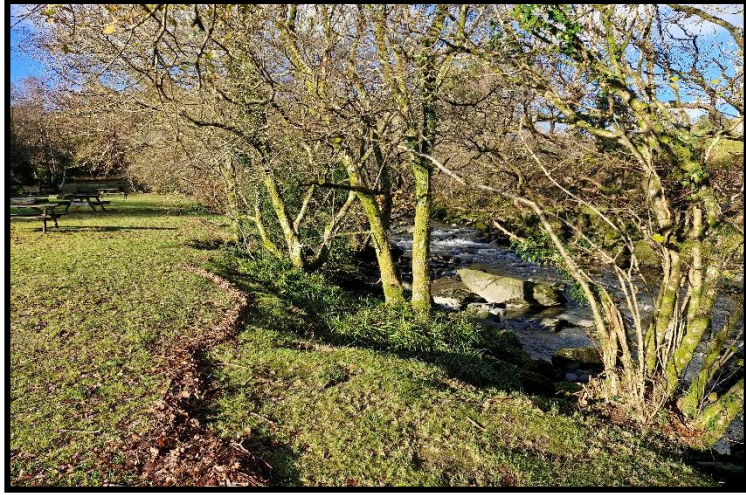
Photograph 15: Compartment 4. Driver edge trees are subject to soil erosion and instability. River flood line visible in foreground

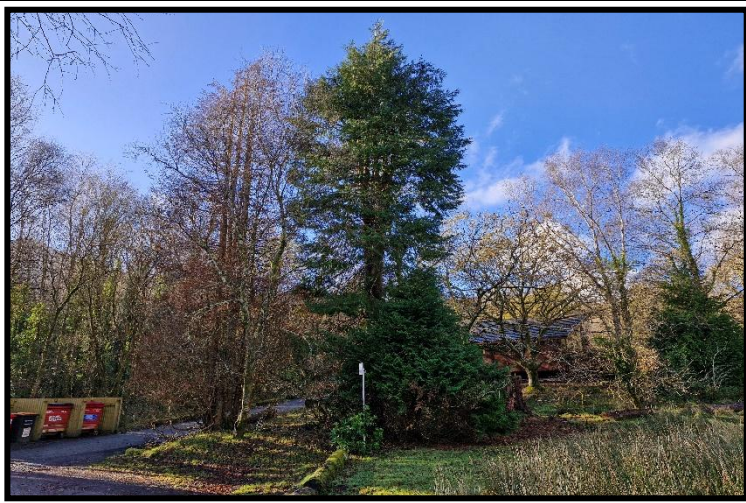
Photograph 16: Compartment 3 and 4. Declining Lawson Cypress (Wind thrown in Compartment 3. Likely due to waterlogged ground conditions.

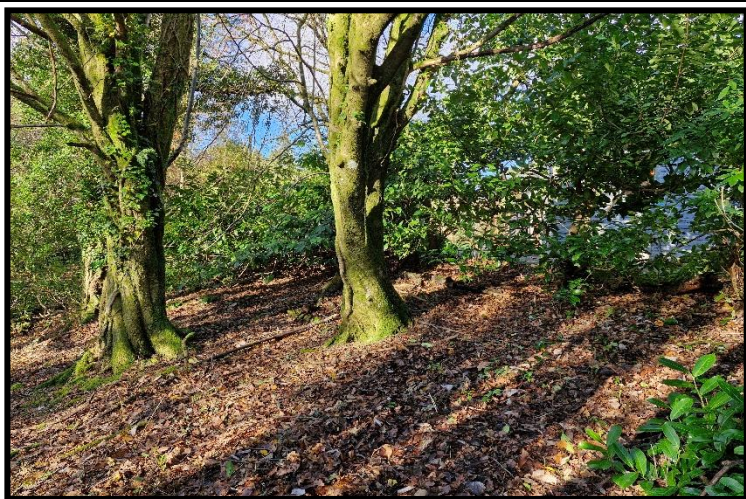
Photograph 17: Compartment 4. Invasive Laurel to rear of the retreat and activity building. Some screening value but requiring eradication and replacement with native woodland planting.

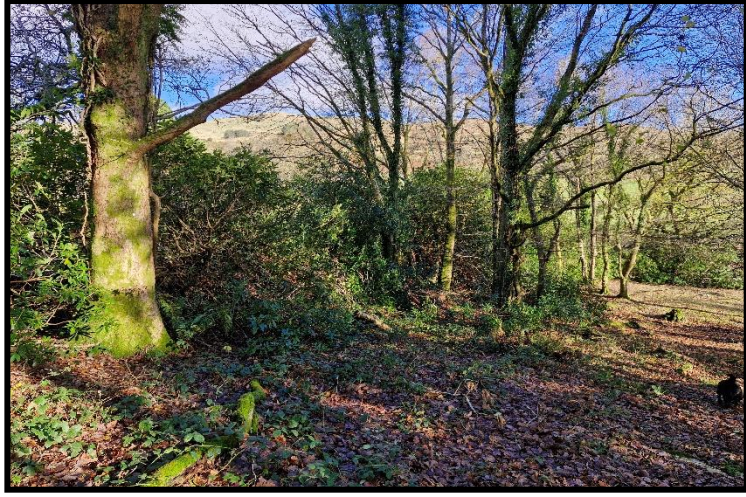
Photograph 18: Compartment 4. Invasive Laurel to rear of the retreat and main drive. Some screening value but requiring eradication and replacement with native woodland planting.
