Arboricultural Report
BS5837:2012 Trees in Relation to
Design, Demolition and Construction
- Recommendations

Blentarn Cadnant Park Conwy LL32 8PE

Document Ref: CPC_0924_5837

Date: 27/09/2024

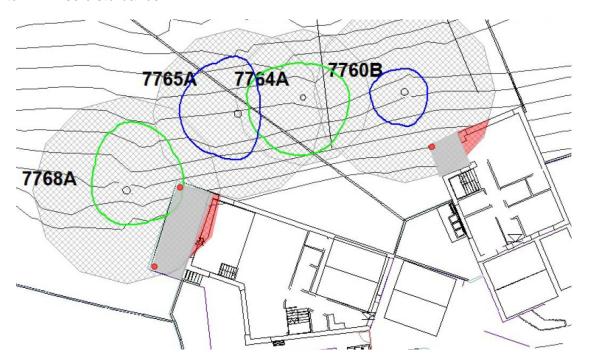
Minor incursion into the root protection area of trees 7760 and 7768 is required as below (shaded red).

The grey blocked out areas on the plan extract denote balconies raised well above the ground and supported by beams of up to 200mm diameter. The location of the beams are identified by the red dots. Should consent be granted the beams will have to be hand dug to minimise disturbance.

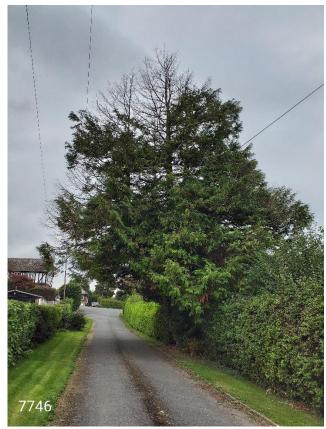
7746 - tree at entrance to site clearly in decline

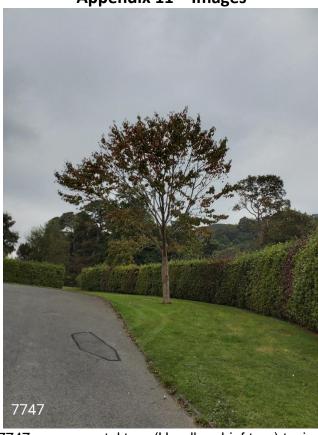
7747 – ornamental tree (Handkerchief tree) typical for the garden area

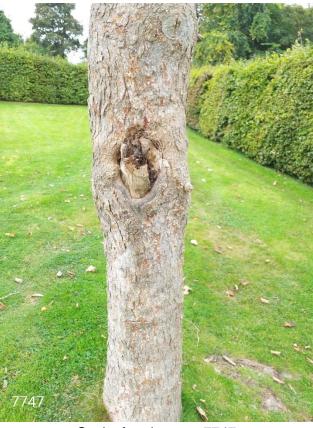
Cavity forming tree 7747

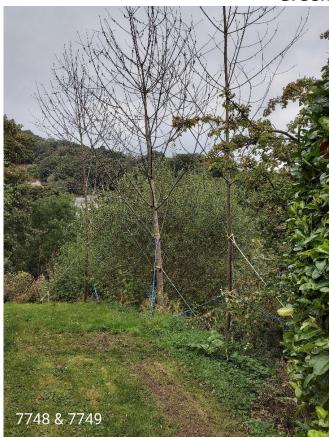
7748 & 7749 – recently planted cherry trees (tree on right too small, <75mm to be included in survey)

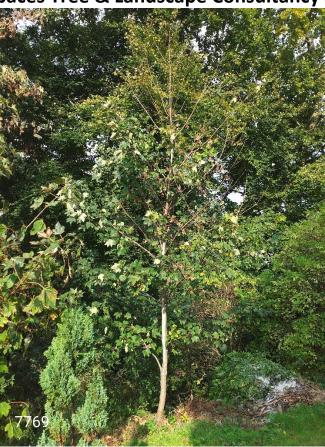
7769 – typical small ornamental proposed for removal

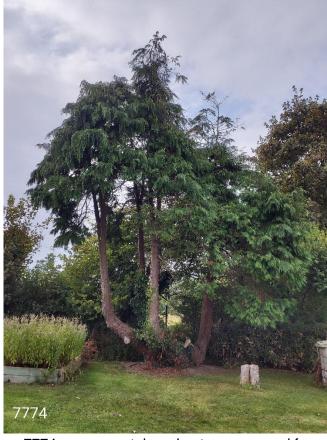
7774 – ornamental garden tree proposed for removal

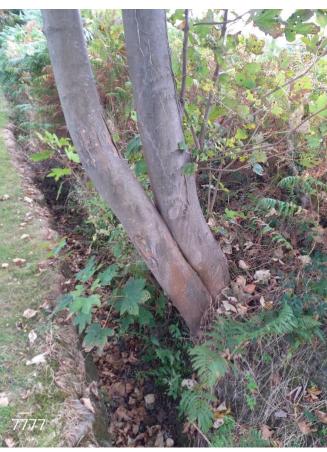
Co-dominant stems with inclusions forming to tree 7777

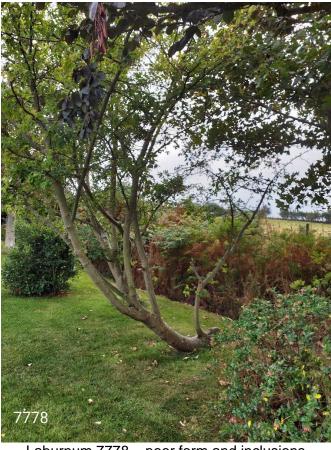
Laburnum 7778 – poor form and inclusions

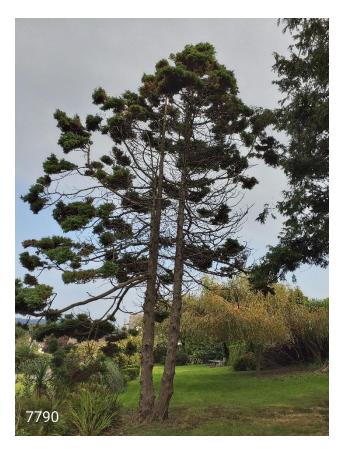
7790 – showing a sparse crown associated with decline

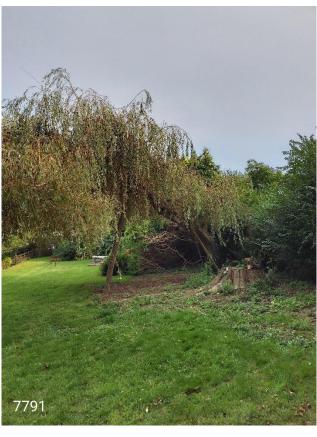
77981 – willow in need of support in order to stay upright

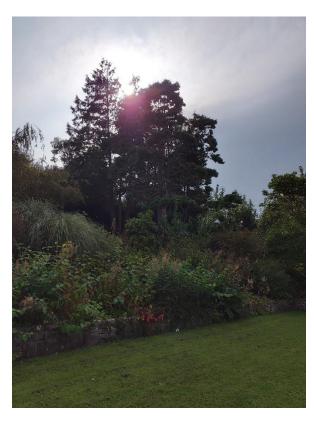
Tree 7790 with trees 7787 – 7789 behind, all proposed for removal
