## **Arboricultural Impact Assessment**

## **Forest Holidays, Beddgelert**

Our Ref: 24/AIA/SNPA/23

August 2024

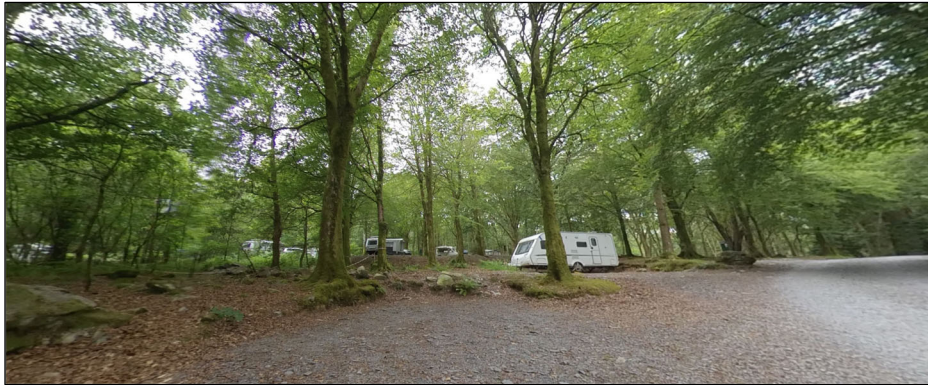
P2 – Existing site with established pitches within woodland setting
