# INFILTRATION TESTING REPORT

PROPOSED RESIDENTIAL DEVELOPMENT LOCATED AT  
34 CADNANT PARK, CONWY

**MÔN CIVILS**  
LIMITED

**March 2024**  
**Revision P01**

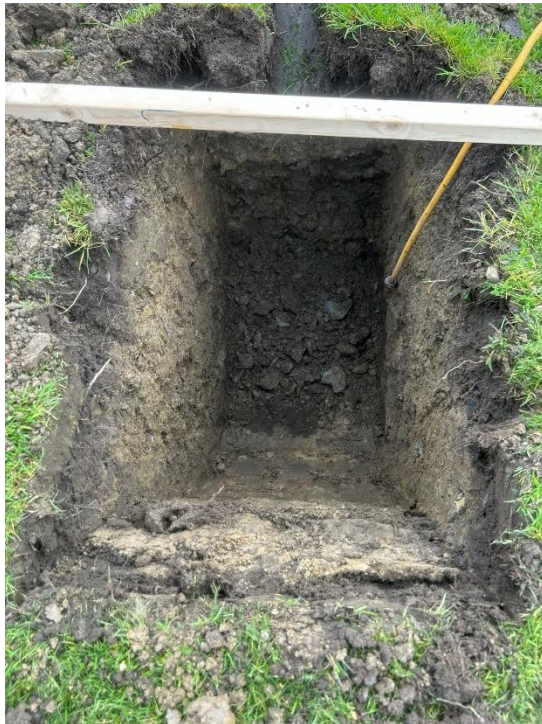
## Trail Pit 1 (TP1)

0.000m – 0.220m	Topsoil: Dark brown made ground. Very sandy, slightly gravelly silt, gravels are fine angular to rounded. Roots & rootlets were present throughout.
0.220m – 1.260m	Light brown made ground, very gravelly clay. Gravels are small to medium angular to sub-angular.
1.260m	Light brown made ground, very gravelly clay. Gravels are medium to large with boulders & broken brick.

1. Trial pit dimensions: 1.200m (L) x 0.700m (W) x 1.260m (D)
2. No ground water was encountered within the trial pit.
3. Sides of trail pit where stable throughout.

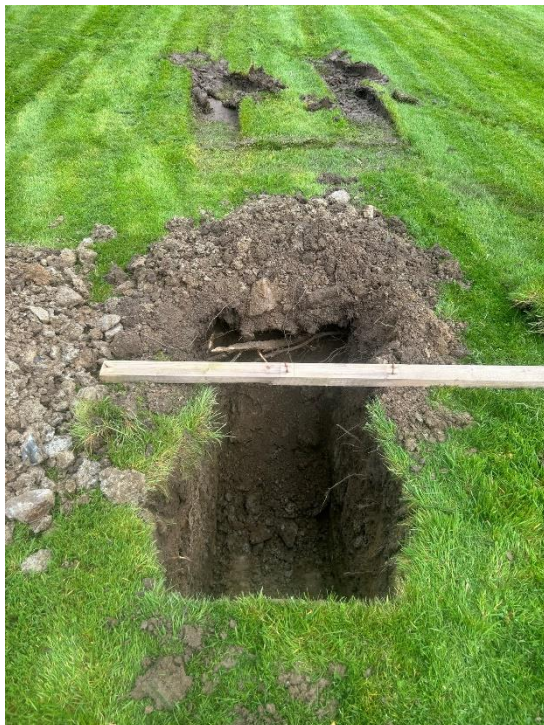
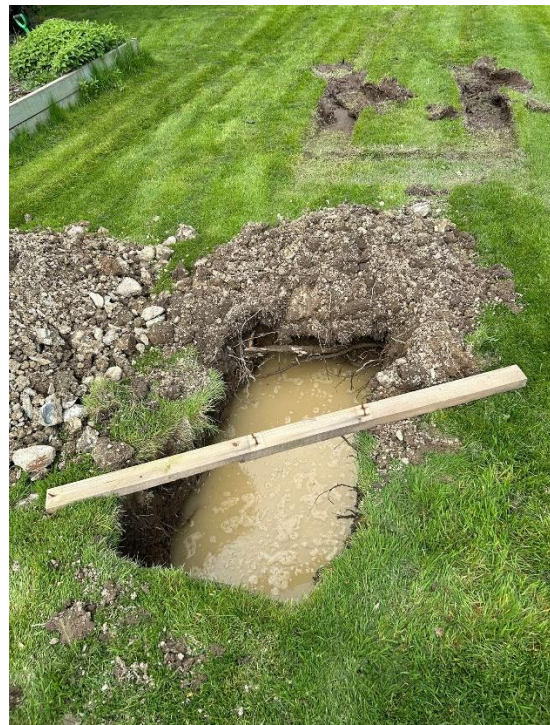
## Trail Pit 2 (TP2)

0.000m – 0.300m	Topsoil: Dark brown made ground. Very sandy, slightly gravelly silt, gravels are fine angular to rounded. Roots & rootlets were present throughout.
0.300m – 1.210m	Light brown made ground, very gravelly clay. Gravels are small to medium angular to sub-angular.
1.210m	Light brown made ground, very gravelly clay. Gravels are medium to large with boulders & broken brick.

1. Trial pit dimensions: 1.300m (L) x 0.750m (W) x 1.210m (D)
2. No ground water was encountered within the trial pit.
3. Sides of trial pit where stable throughout.

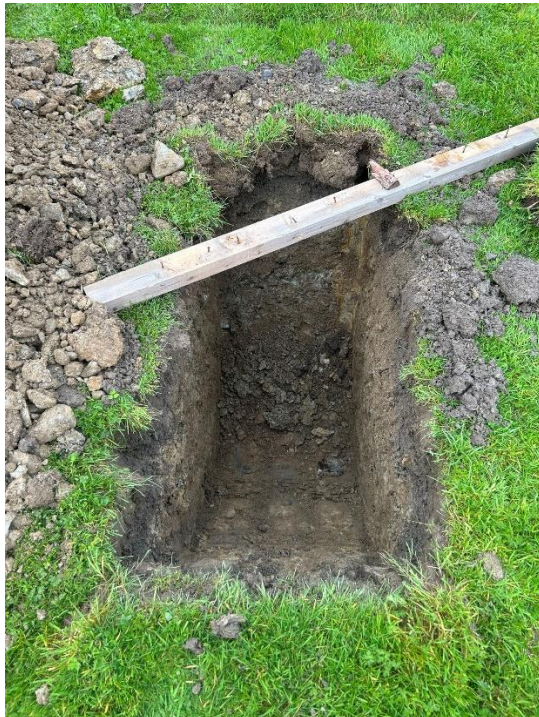
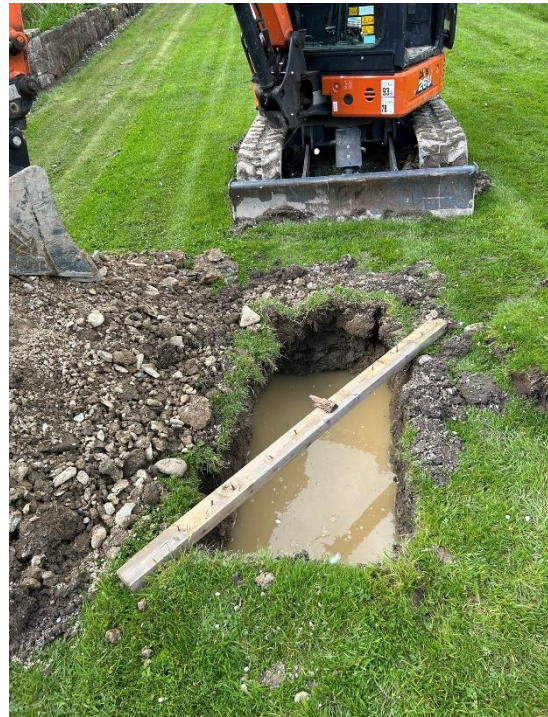
## Trail Pit 3 (TP3)

0.000m – 0.300m	Topsoil: Dark brown made ground. Very sandy, slightly gravelly silt, gravels are fine angular to rounded. Roots & rootlets were present throughout.
0.300m – 1.130m	Light brown made ground, very gravelly clay. Gravels are small to medium angular to sub-angular.
1.130m	Light brown made ground, very gravelly clay. Gravels are medium to large with boulders & broken brick.

1. Trial pit dimensions: 1.400m (L) x 0.750m (W) x 1.130m (D)
2. No ground water was encountered within the trial pit.
3. Sides of trial pit where stable throughout.
