PHASE 2 GROUND INVESTIGATION: TY HAPUS, LLANDUDNO

GSL3222/RO1

04 MARCH 2025

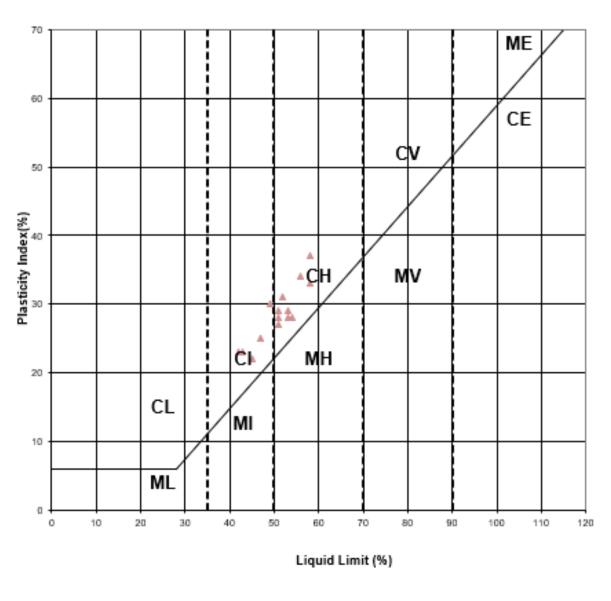
Figure 3: A-Line plot by Geology

Soil classification tests were carried out on the Tidal Flat Deposits which when plotted against the A-line, Figure 3 indicated clays intermediate to high plasticity, with liquid limits ranging from 42% to 58%, plastic limits ranging from 19% to 26%, a plasticity index between 22% and 37%, and a moisture content ranging from 25% to 35%. All results are presented in Appendix F.

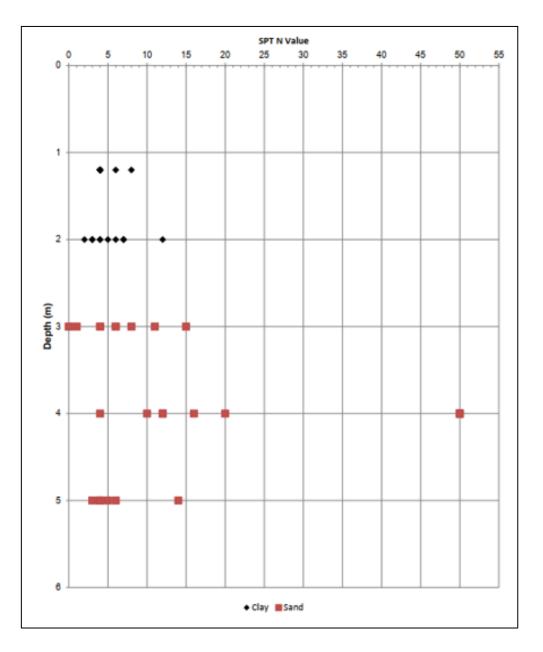
Figure 4: SPT N-Value Vs Depth

A total of 46 Standard Penetration Tests (SPT) were completed within the exploratory holes recording a considerable range of N-Values from 0 to 50. When separated by strata type and plotted against depth, Figure 4. It can be seen the lower bound values are in the lower clay and upper granular strata between 0 and 4 with values consistently at very soft to soft and very loose respectfully.

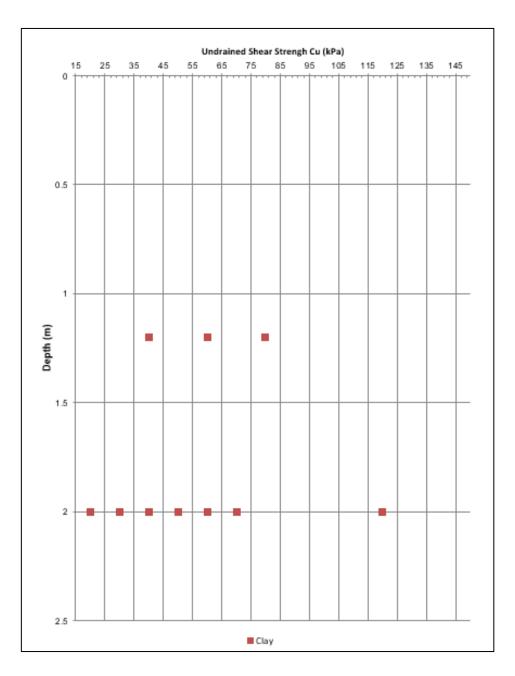
Figure 5 - Undrained Shear Strength Vs Depth

Stroud, 1975 was used to derive undrained shear strength for the clay material utilising an f₁ value of 5. Strength Vs depth plots for the clay material is broadly consistent across the site ranging between 30 to 80kPa (low to high strength) within the upper 2.00m, with an outlier of 120 kPa (High strength) at WS103 at a depth of 2.00m. A Quick Undrained Triaxial test was also undertaken on combined bulk disturbed samples recovered from the upper TFD, comprising of clay strata which was determined to be consistent with derived values.

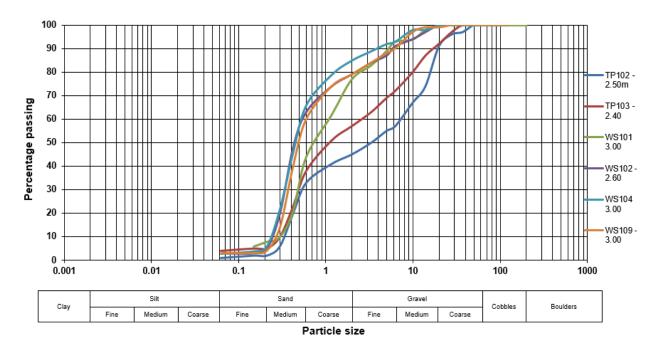
Figure 6: PSD Grading Curves by Geology

A total of seven Particle Size Distribution (PSD) tests were carried out on bulk samples the results of which are summarised in Figure 6 below. The results confirm the engineers descriptions with the TFD, with a minimum fines content of 1% for the TFD. Grading curves for the various material types are shown in **Figure 6**

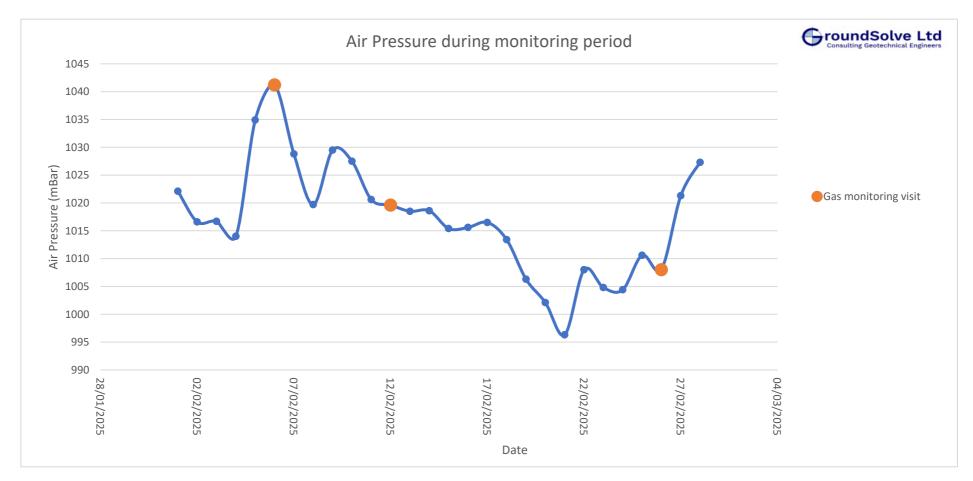
Note: Air pressure data from Liverpool John Lennon Airport Weather Station

The graph in Appendix F show that 2 of the 3 visits to date were carried out during falling air pressure conditions.

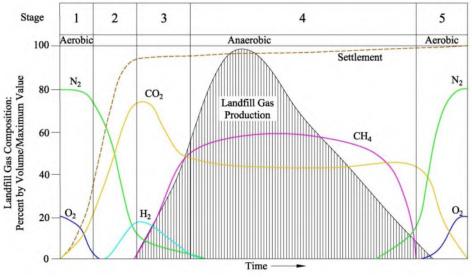
Figure G2. Idealised Representation of Landfill Gas Generation.

Figure G2 is taken from EA guidance document LFTGN 03 illustrates typical ground gas generation curves from biodegradable materials:

The production of methane and carbon dioxide at a landfill site may be expected to be considerable and ongoing. Concentrations of methane will eventually decrease, followed by concentrations of carbon dioxide, but the duration and rate of gas production can vary markedly between sites. Five distinct phases of gas production occur during the process which are, in order of event (as marked on Figure G2), as follows:
