**ABERLLEFENNI SLATE QUARRY**  
**PRN: 20487**  
**NGR: SH 7681 1021**  
**ARCHAEOLOGICAL ASSESSMENT**  
**and**  
**EVALUATION OF SETTING ISSUES**  
for David Meredith and Sons  
October 2023  
**Govannon Report GC463**

## **ABERLLEFENNI SLATE QUARRY – ARCHAEOLOGICAL ASSESSMENT**

Govannon Consultancy has been commissioned by David Meredith and Sons to carry out an archaeological assessment of three discrete sites of slate waste tipping at Aberllefenni Slate Quarry (the present document) to inform a proposed planning application and an EIA screening request.

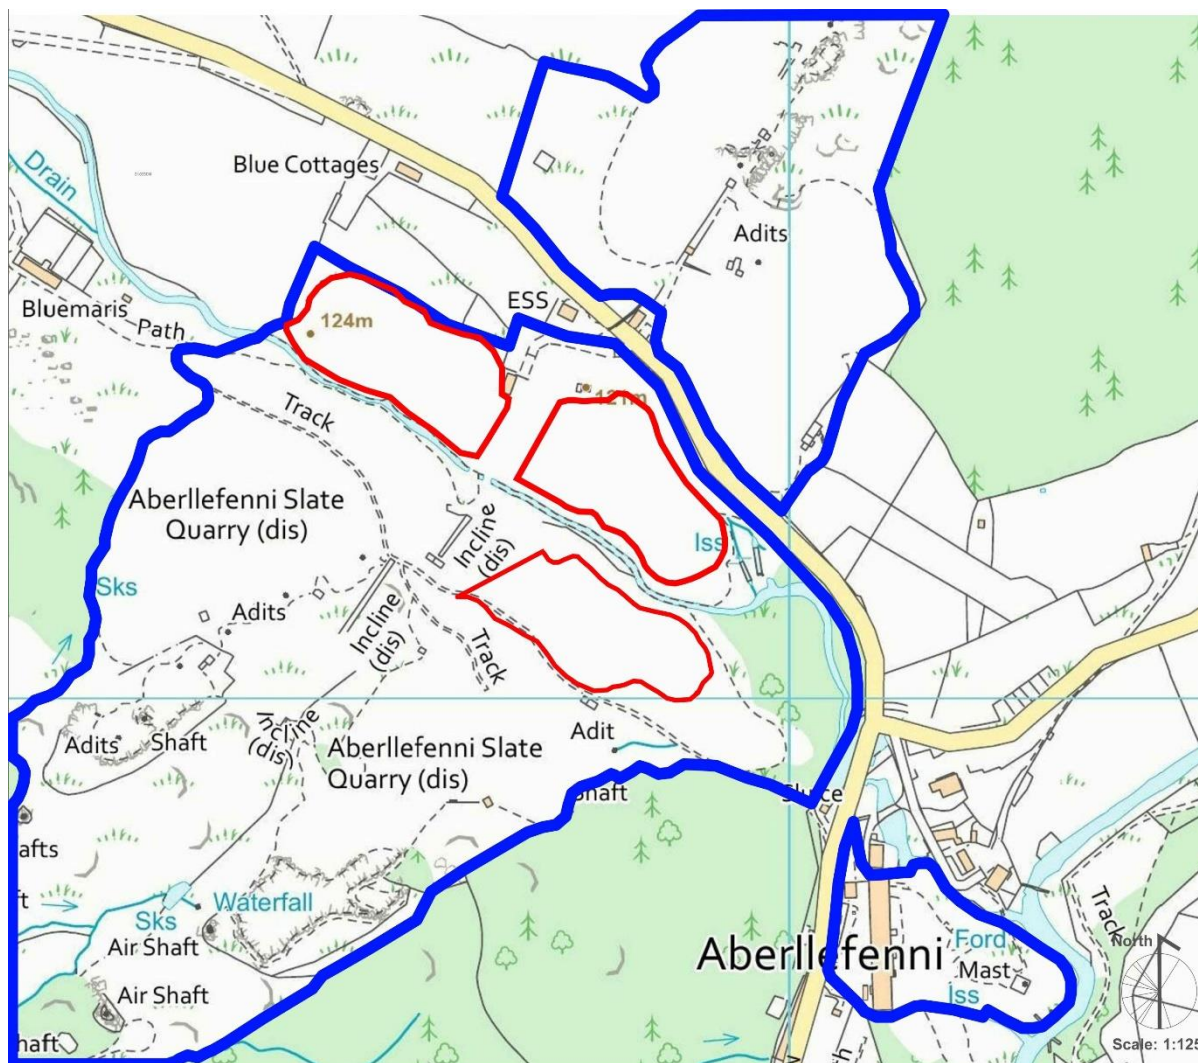
**Map 1:** Aberllefenni Slate Quarry, areas of proposed development in red.

It is proposed to remove waste slate rock from these three sites for sale as aggregate.

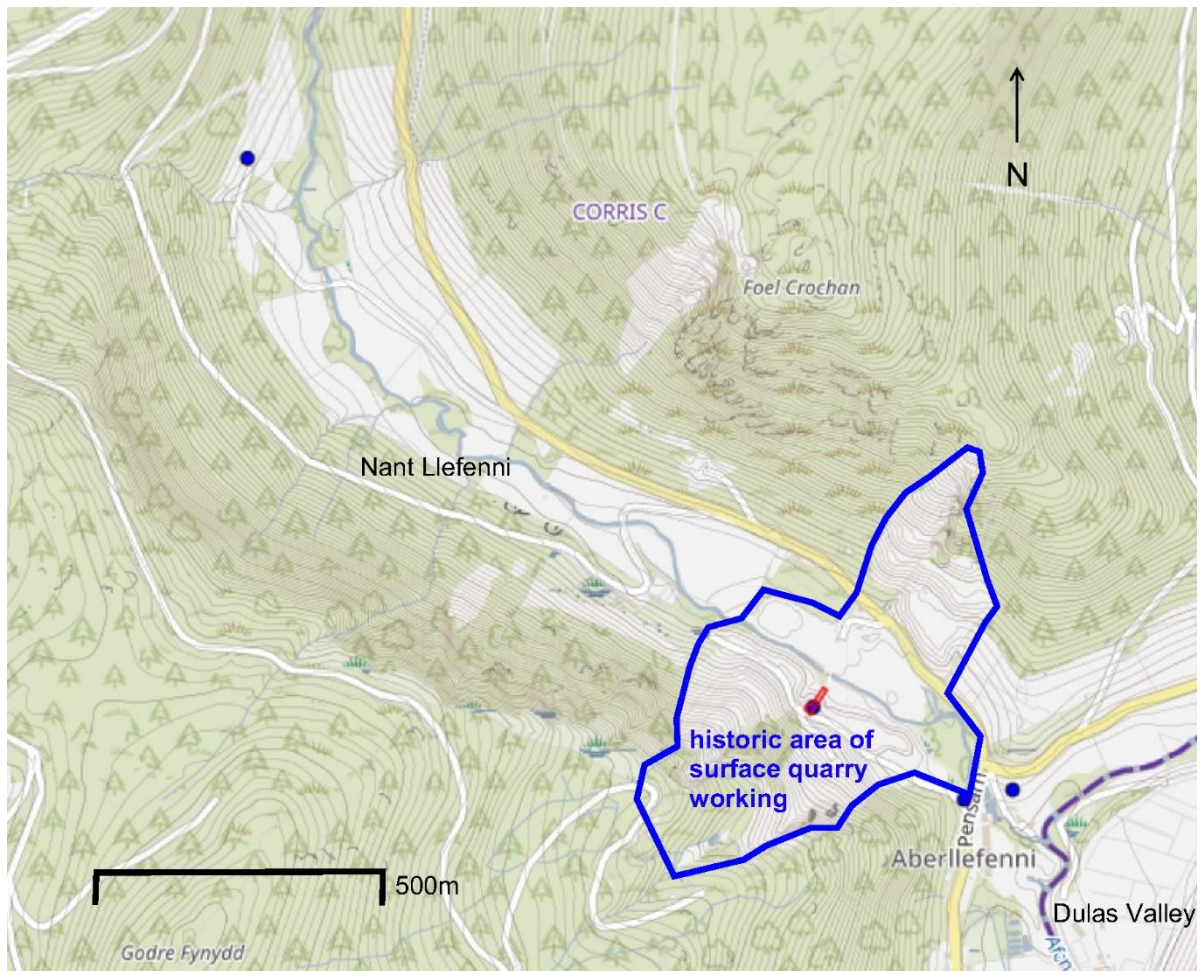
**Map 2:** Aberllefenni Slate Quarry, Nant Llefenni and the Dulas Valley.

A vein of Ordovician slate runs across Nant Llefenni from south-west to north-east, dipping at 70° to the southeast. The valley floor in the vicinity of the Aberllefenni Slate Quarry lies at 115m AOD. The proposed development consists of three areas of slate waste tipping which are located in close proximity to each other within the Aberllefenni Slate Quarry complex.

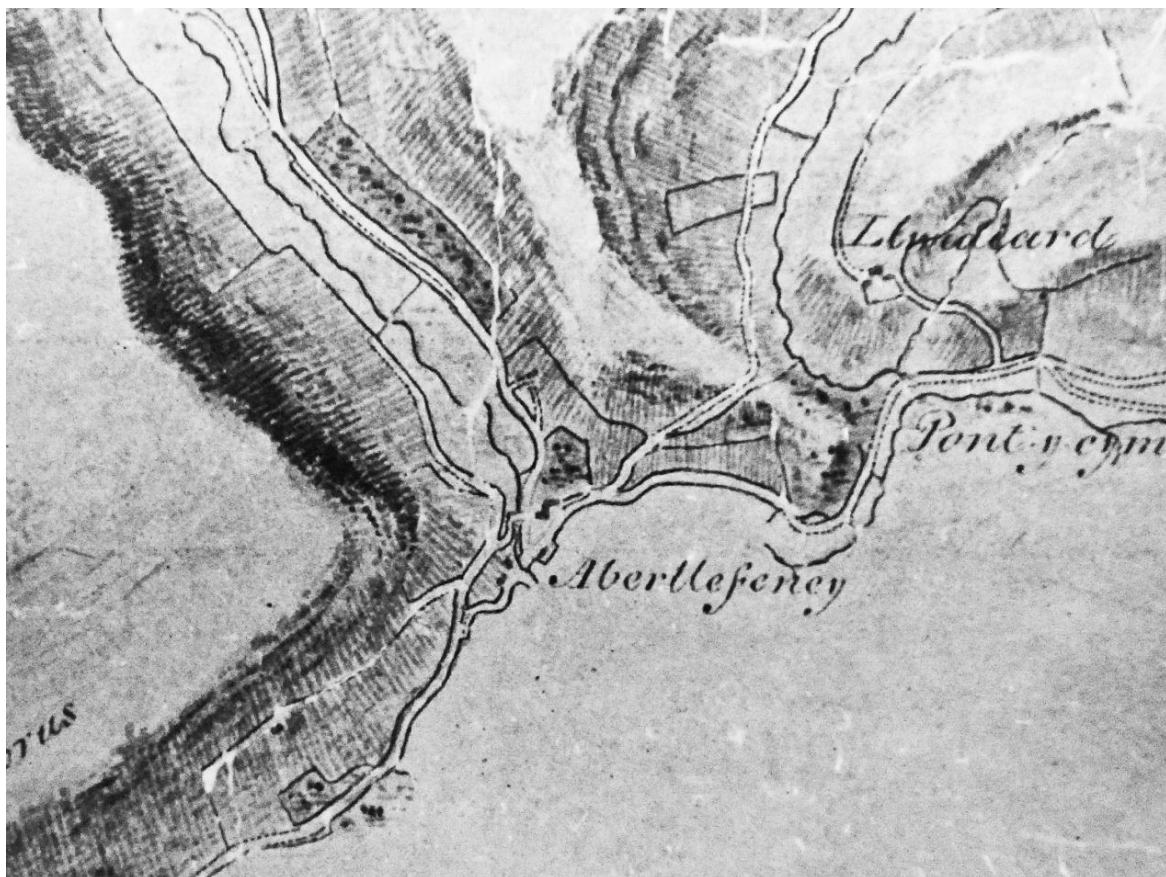
**Map 3:** 1816 Ordnance Survey surveyors' drawing of 'Aberllefenny'. Copyright Ordnance Survey.

The 1816 survey shows a wooden enclosure on the north-east side of Nant Llefenni, and a walled area on the south-east and the river flowing through meadows, and a system of roads and tracks. Slate quarrying has clearly not yet made any significant impact on the landscape.

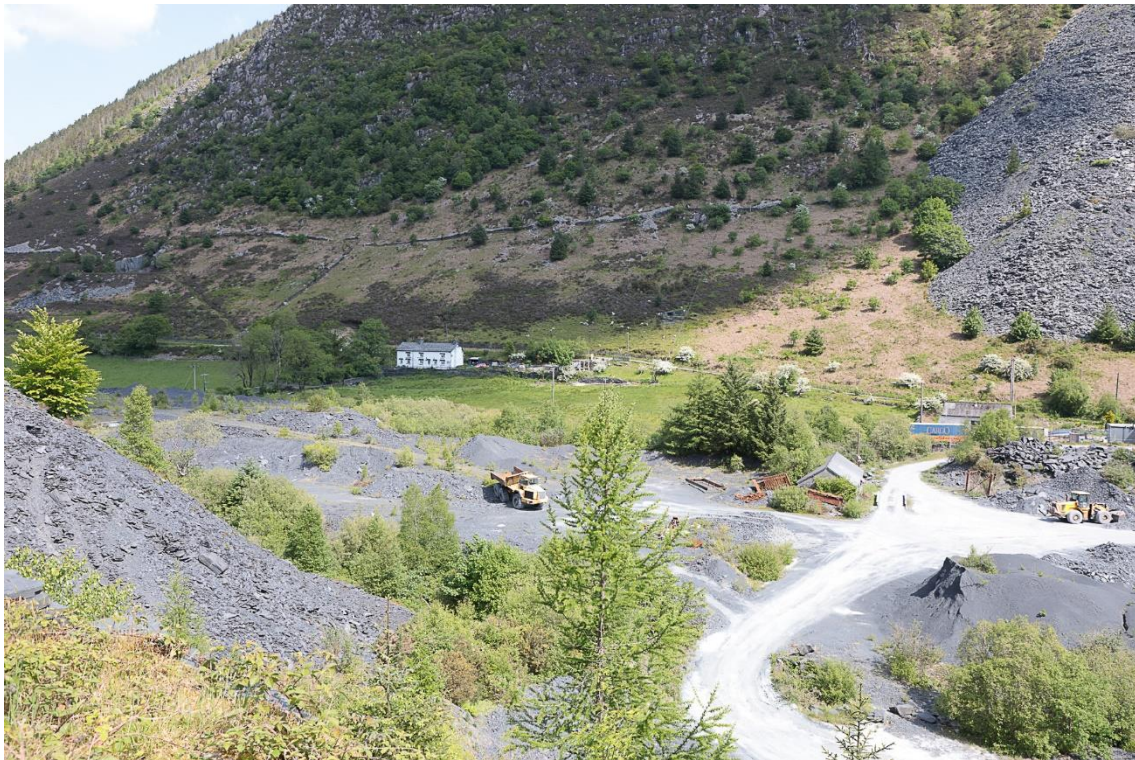
**Figure 1:** (1) viewed from the south-east.

**1 Degraded slate tips (valley floor tip [a])**

A poorly-preserved and degraded example of a common site-type, with some group value with the quarry landscape as a whole, and with some archaeological potential in the event of re-working.

*Threat:* Reworking of waste rock; potential removal of feature.

*Mitigation:* Watching brief.

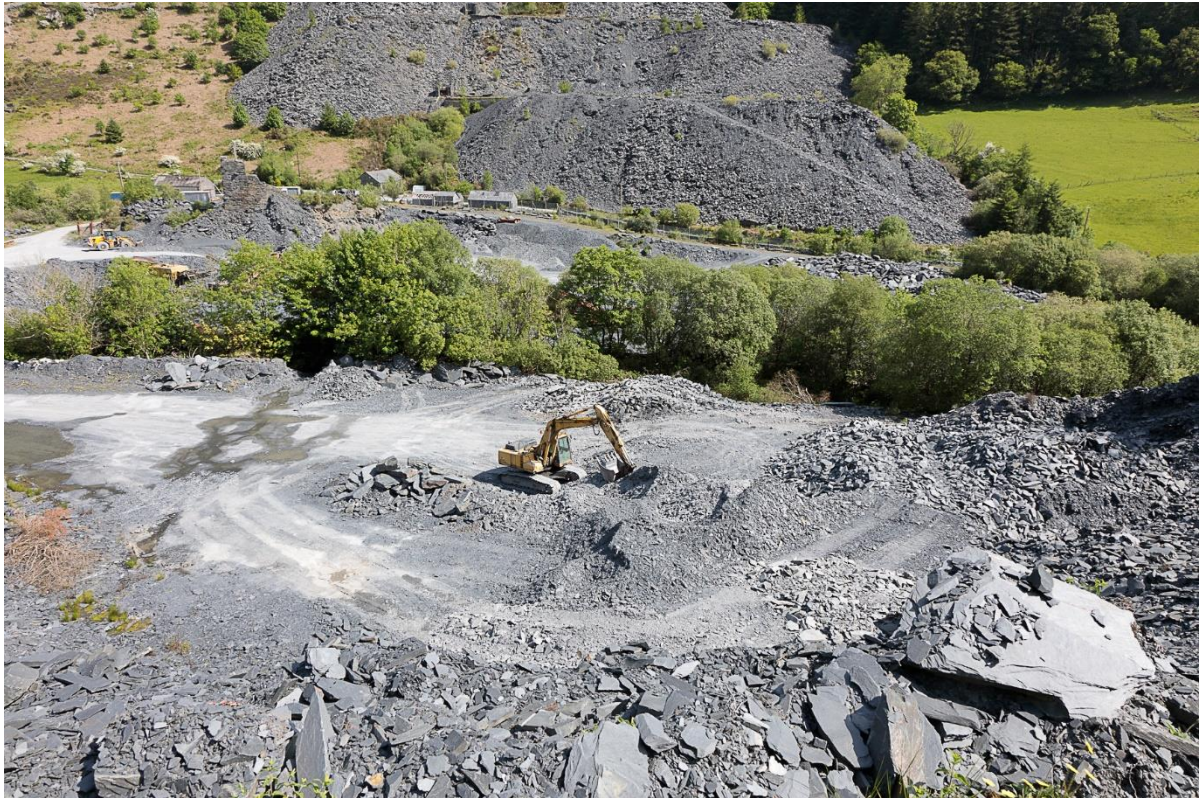
**Figure 2: (2)** viewed from the south-west showing the extent of secondary working in the 19<sup>th</sup> century tip. The site occupies the foreground of the photograph as far as the tree-growth along the valley-floor stream; the Foel Grochan workings (PRN: 67512) are evident in the background.

## 2 Crushing yard slate tip

A poorly-preserved and degraded example of a common site-type, with some group value with the quarry landscape as a whole, and with some archaeological potential in the event of continued secondary working.

**Threat:** Reworking of waste rock; potential removal of feature.

**Mitigation:** Watching brief.

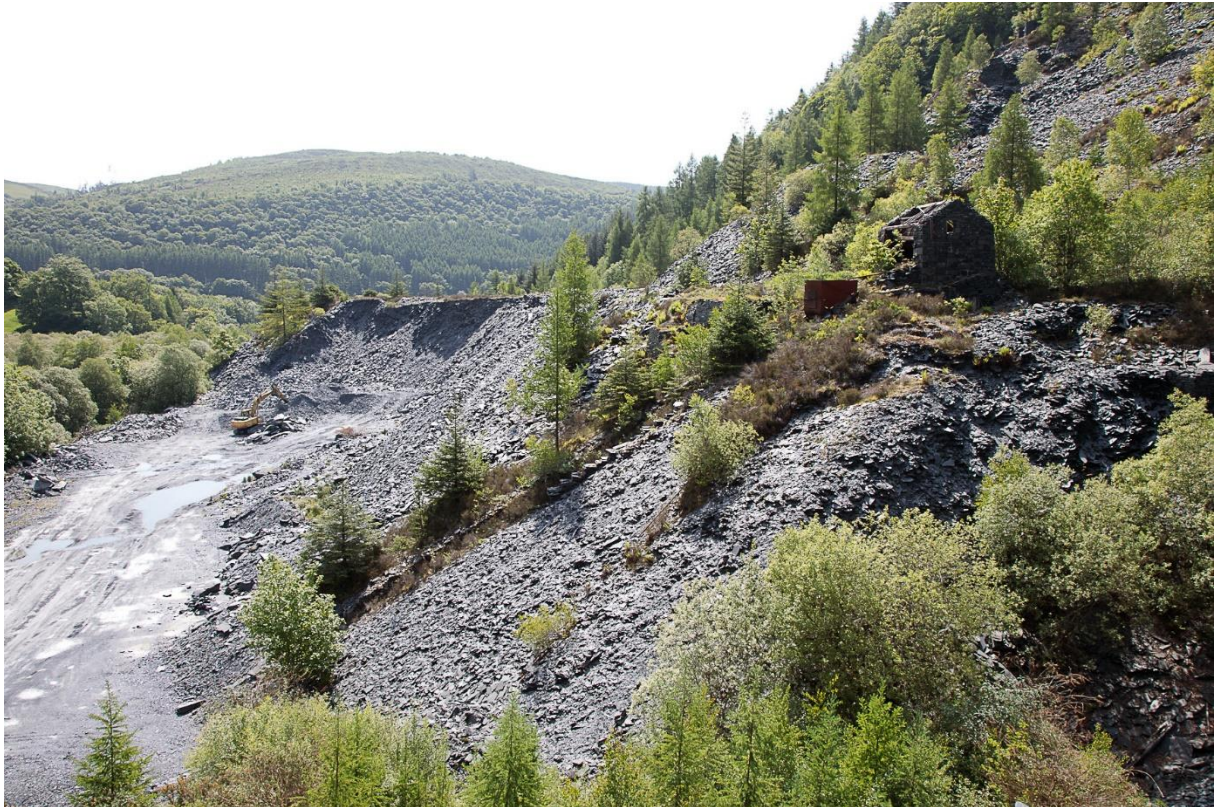
**Figure 3:** (3) viewed from the north-west showing the extent of secondary working in the 19<sup>th</sup> century tip. The Scheduled inclined plane (PRN: 18288) is evident in the foreground.

### 3 Southern slate tip

The tips are vulnerable to damage and removal due to continued secondary working of the slate waste.

*Mitigation:*

Watching brief; agreement as to possible extent of re-working.

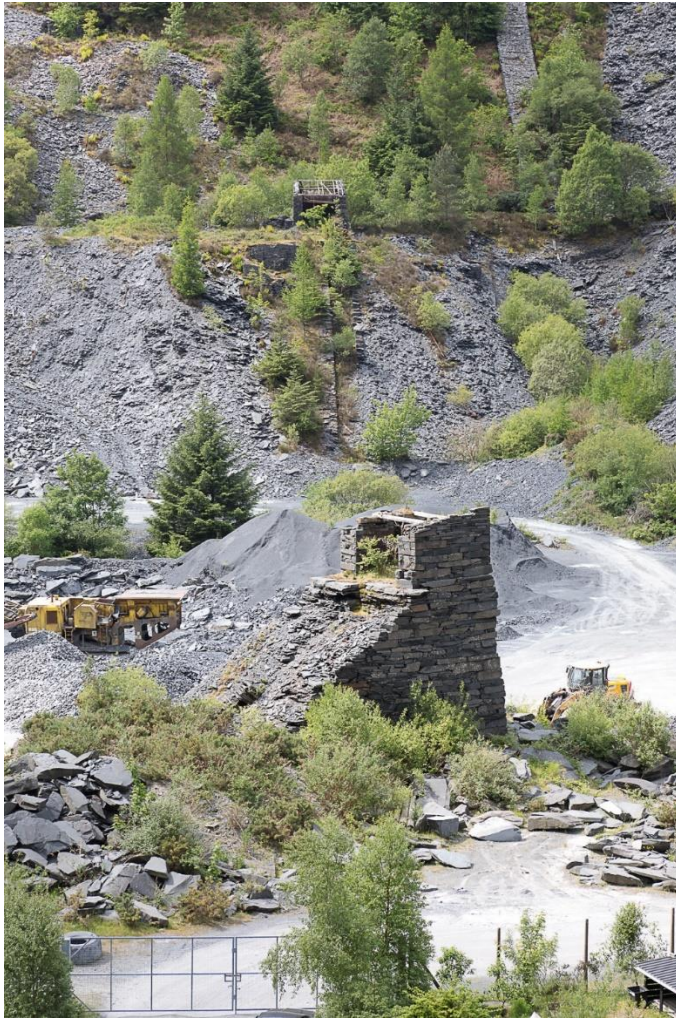
**Figure 4:** (4) and (5) in the foreground, viewed from the north-east. The Scheduled inclined plane (PRN: 18288) is visible in the background.

#### 4 Incline uphaulage waterbalance

Vulnerable to reworking and to further deterioration in the structure.

*Mitigation:*

Avoidance; Recording Level 4

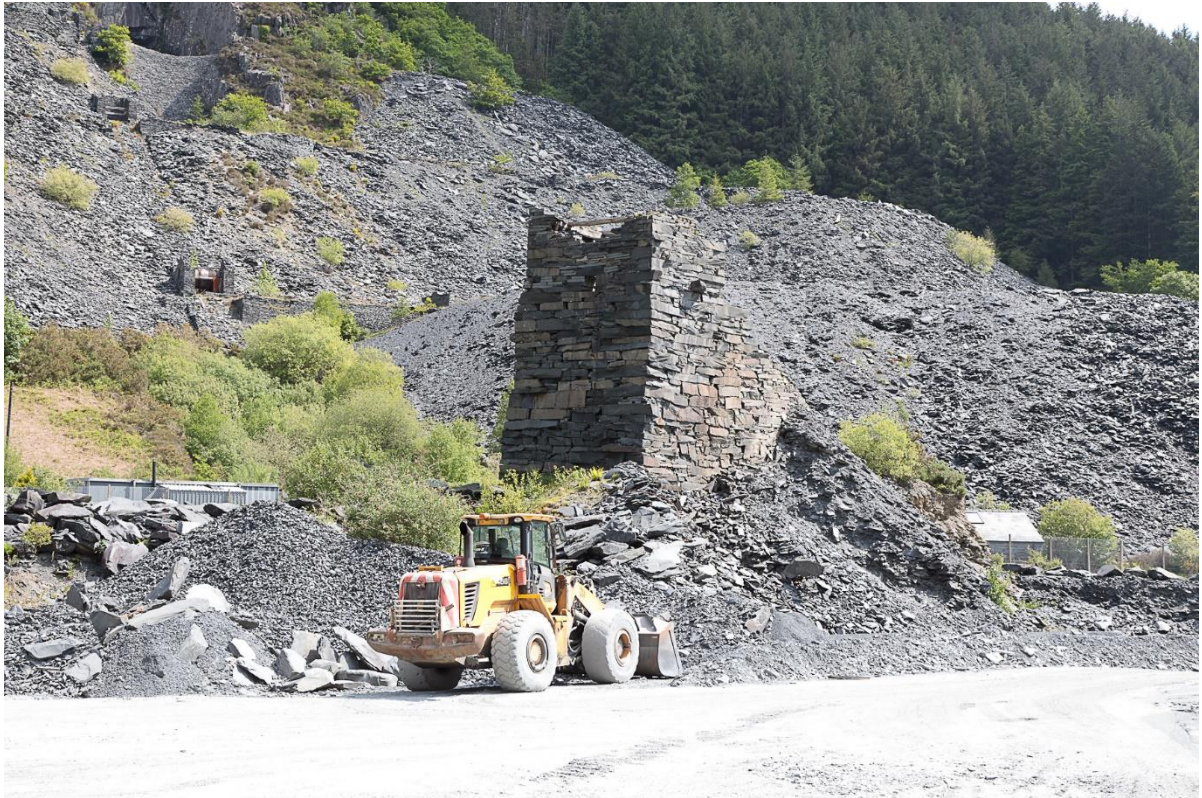
**Figure 5:** (4 and 5) viewed from the west, with Foel Grochan in the background.

**5 Incline winding house waterbalance**

A well-preserved and well-documented example of a distinctive site-type in the context of the Welsh slate industry, with outstanding group value with the quarry landscape as a whole, with feature (4), and with the other inclined planes in particular. This feature lies adjacent to the proposed area, and is vulnerable to reworking and to further deterioration in the structure.

*Threat:* Further deterioration

*Mitigation:* Avoidance; Recording Level 4

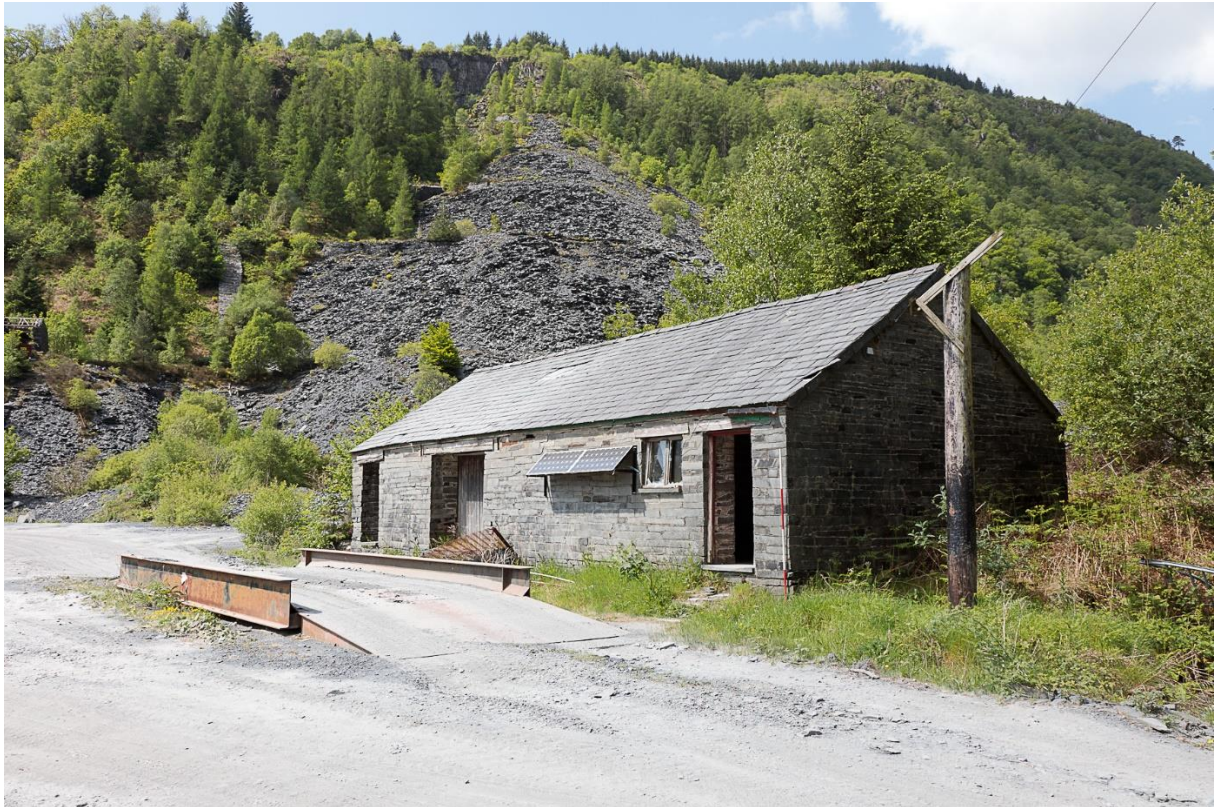
**Figure 6:** (6) viewed from the east.

**6 Compressor house**

A well-preserved and well-documented structure from the later period of quarrying on site. Compressor houses are commonly found in slate quarries from the early 20<sup>th</sup> century.

*Mitigation:*

Watching brief.

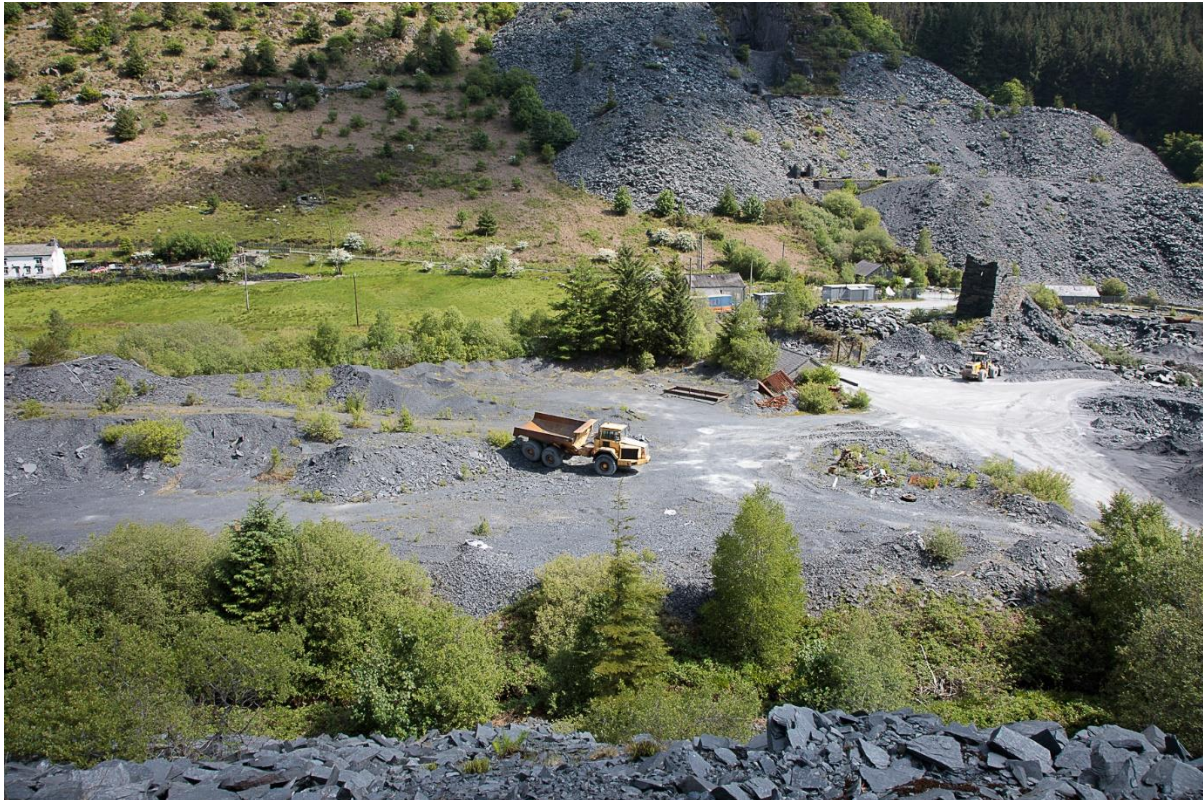
**Figure 7:** The inferred site of (7) is indicated by the pine trees, centre.

**7 Mill**

*Threat:* Secondary working of waste rock; possible damage to site.

*Mitigation:* Watching brief.

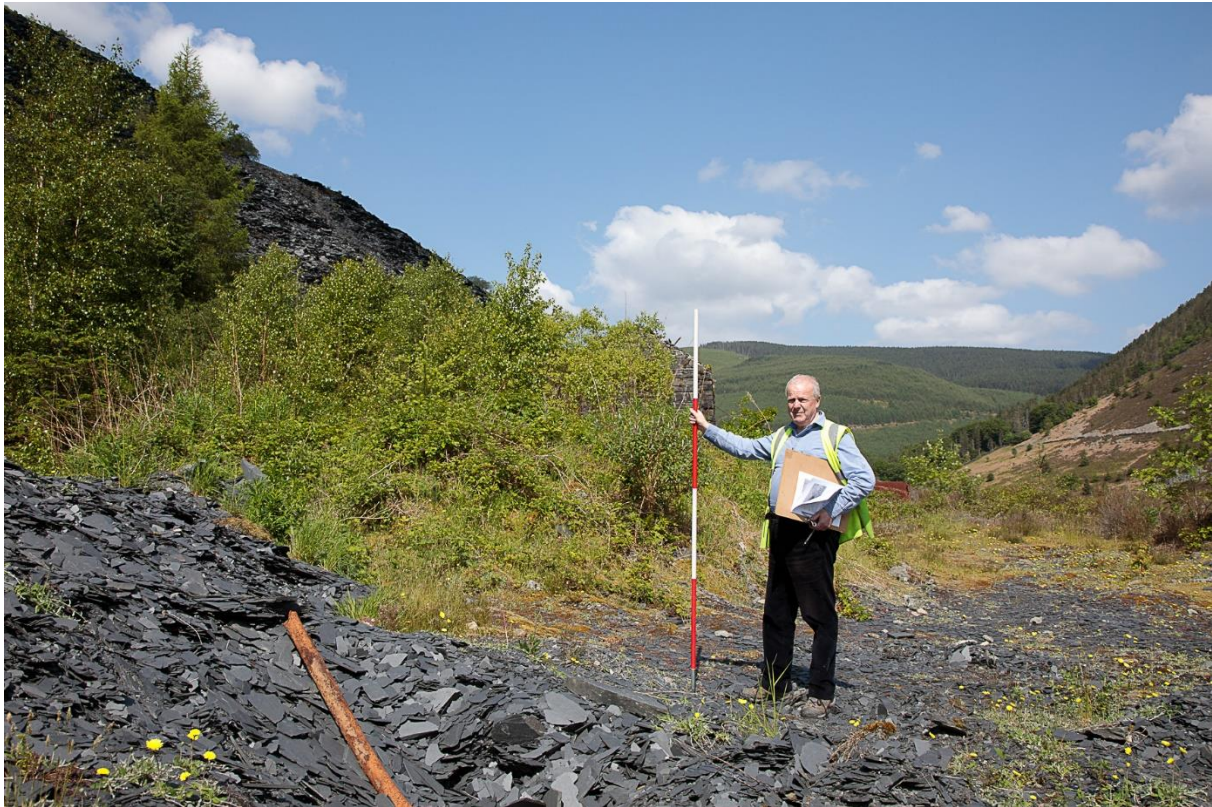
**Figure 8: (8) viewed from the south-east.**

**8 Slate mill (possible site of)**

*Location:* SH 76766 10082  
*Period:* Post-Medieval/Modern  
*Description:* The location of a slate mill ('mill 6') dating from the late 19<sup>th</sup> century, which may be represent by a pile of rubble at SH 76766 10082.  
*Significance:* E  
 Potentially significant as a nineteenth century slate-slab mill.  
*Threat:* Secondary working of waste rock; possible damage to site.  
*Mitigation:* Watching brief.

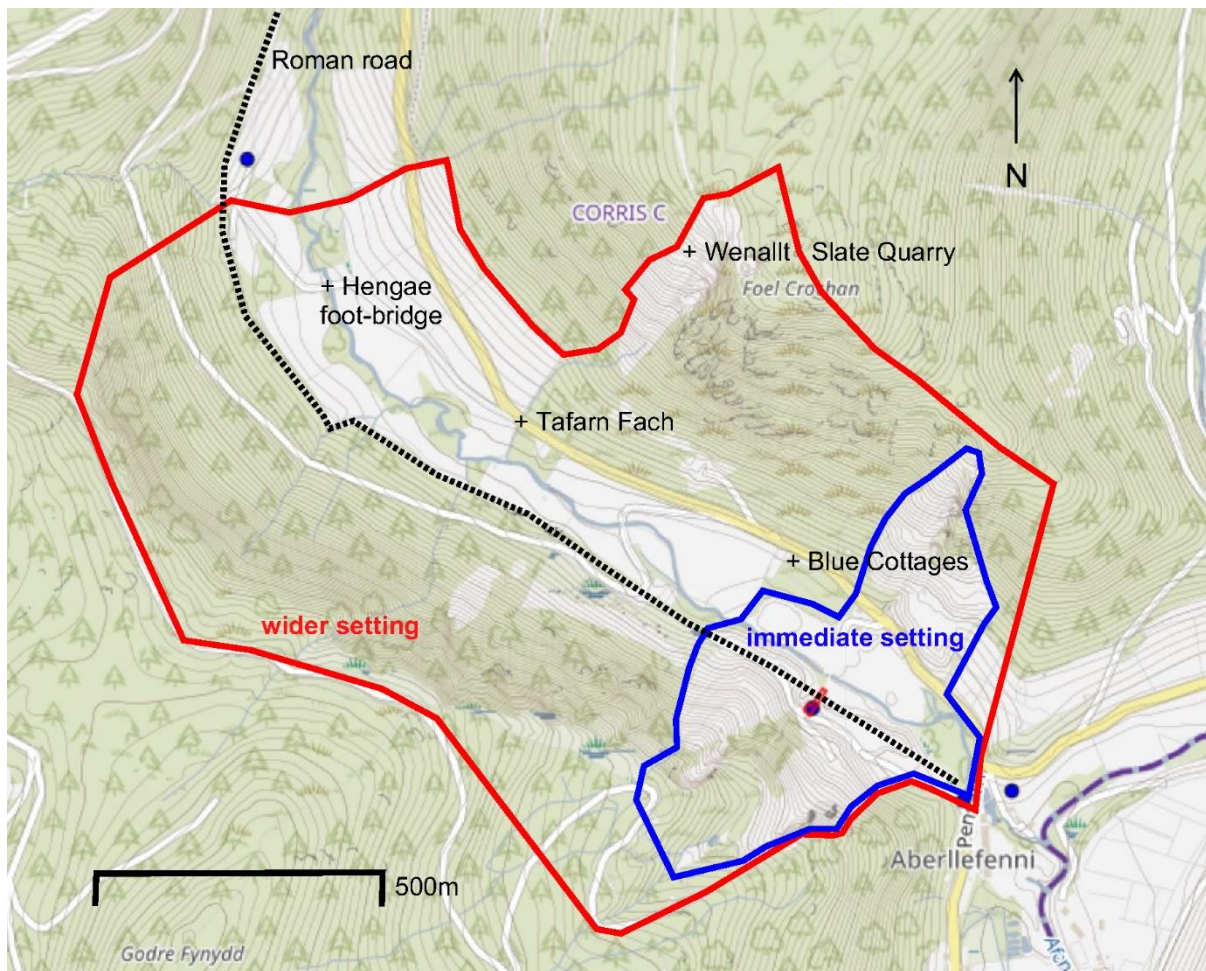
**Map 10:** Immediate setting and wider setting.

A distinction may be drawn between the *immediate setting* of the quarry itself, an historic environment of slate-extraction and tipping and its associated handling systems within which there is considerable inter-visibility due to the valley topography, and a *wider setting*, the effective zone of visibility for the proposed developments as a whole, extending from the ridge tops to north and south to the western point in Nant Llefenni where the proposed developments would cease to be apparent and to the causeway at SH 77032 09963 (PRN: 74896) which effectively closes it off to the east. This wider setting is appropriate in that the proposals would affect an historic environment of which slate-extraction and tipping and associated handling systems form a part, but which also includes the rural economy out of which the quarry grew and within which it functioned (**map 10**).

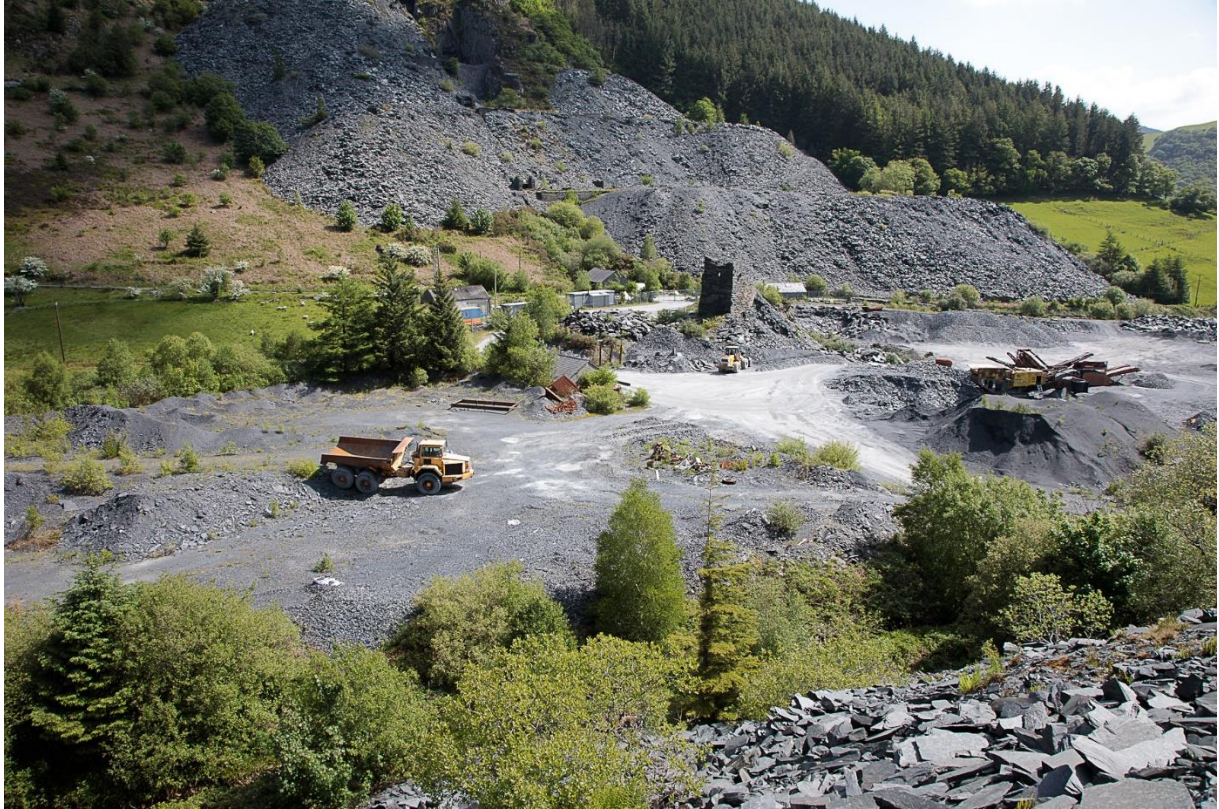
**Figure 9:** *The immediate setting of the proposed development displays strong inter-visibility between historic assets.*

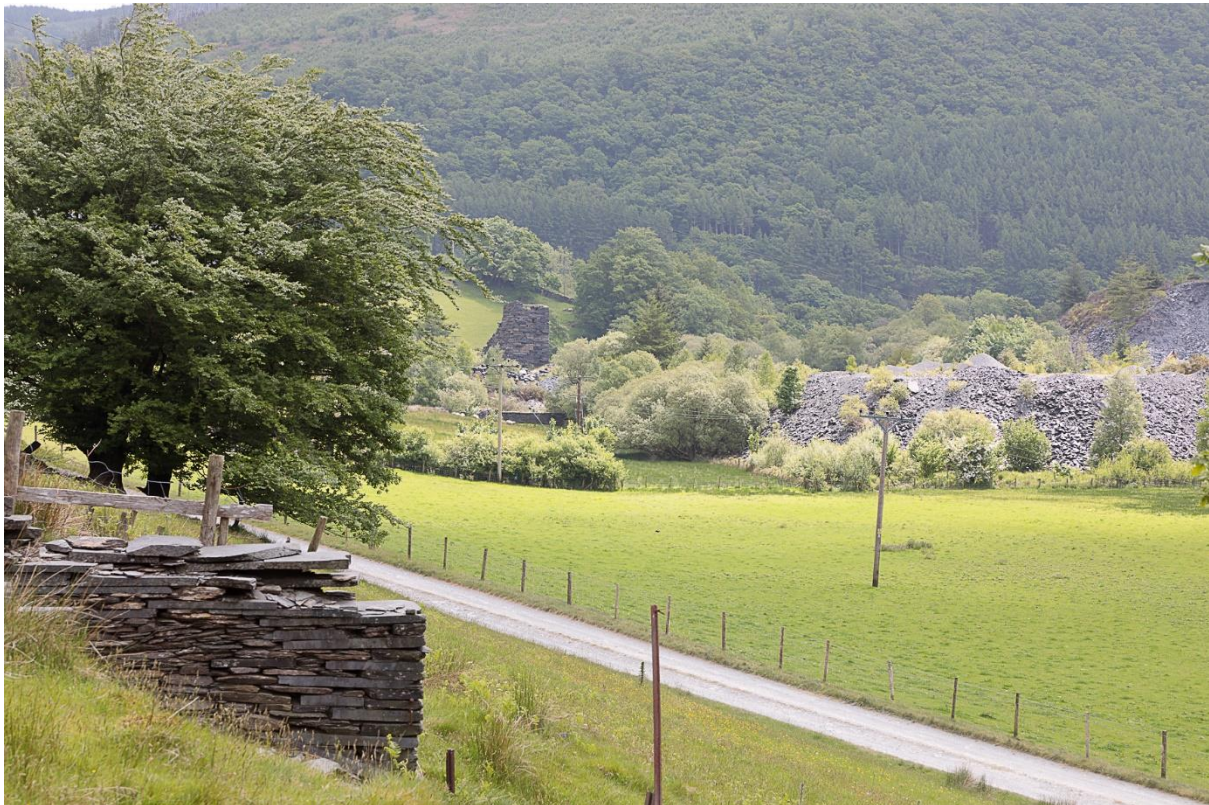
**Figure 10:** *Reworking of the southern tip is distantly apparent in this view from the Cambergi/Wenallt Slate Quarry mill.*
